Churches of Lesvos

**A Preservation Study for the Katholikon
of Moni Perivolis and Other Historic Churches**

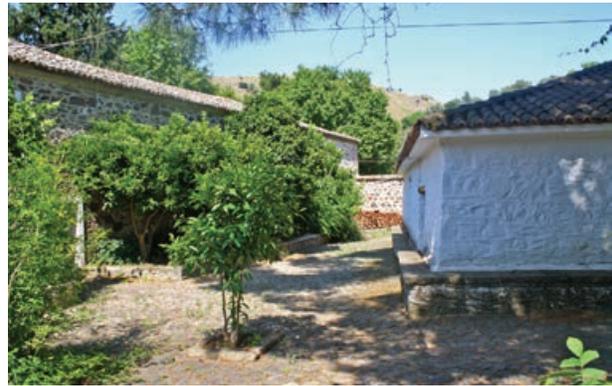
FIGURE 14 Northwest corner of the church with exterior bench

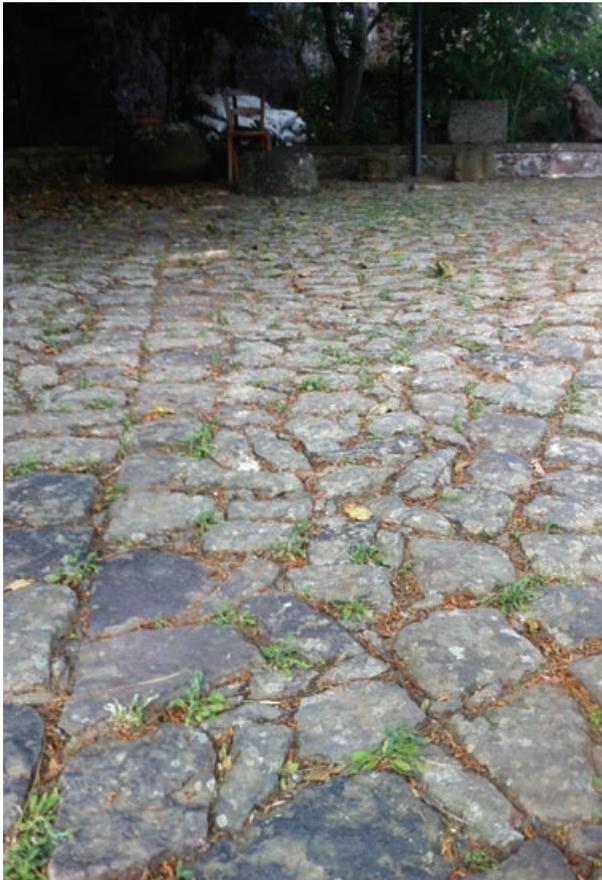
The rivulets in the paving system stones that are aligned long edge to long edge appear to be performing properly during rain events (Figure 15). One adverse condition in the drainage system is the blocking of some of the channels in front of the main entrance with a layer of hydraulic cement (Figure 16).

FIGURE 15 Traditional surface drainage system

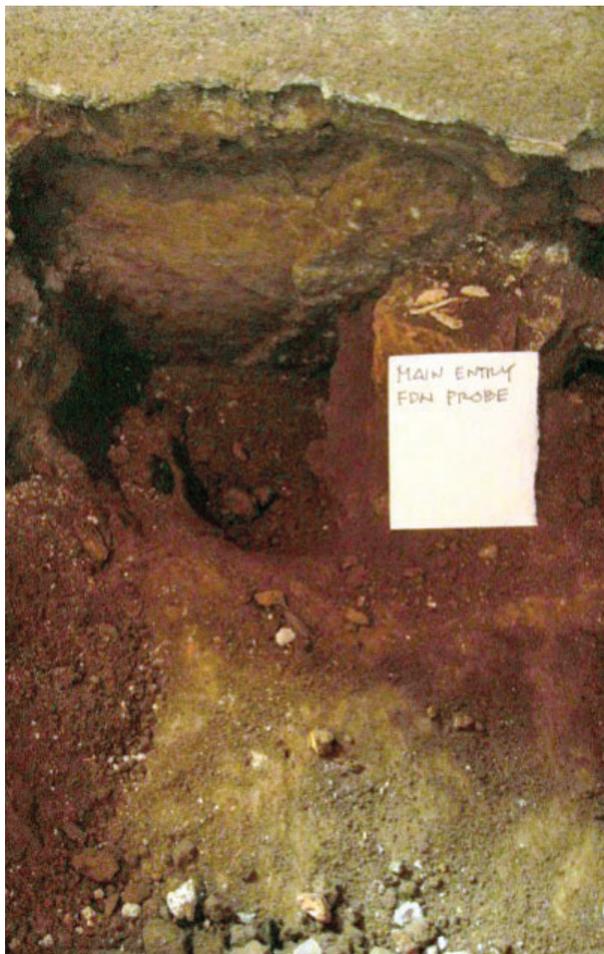
FIGURE 20 Walls penetrate the ground at least 40 centimeters, but lack footings

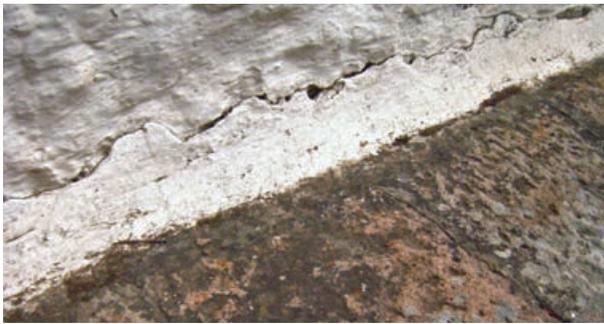
FIGURE 25 A hydraulic cement cant at the bench edges entraps moisture. Note the typical gap at the rear upper edge, a result of differential expansion and contraction.

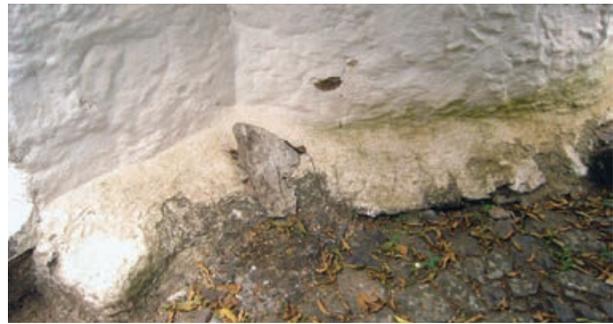
FIGURE 26 Walls lacking exterior benches meet the ground with a hydraulic cement cant

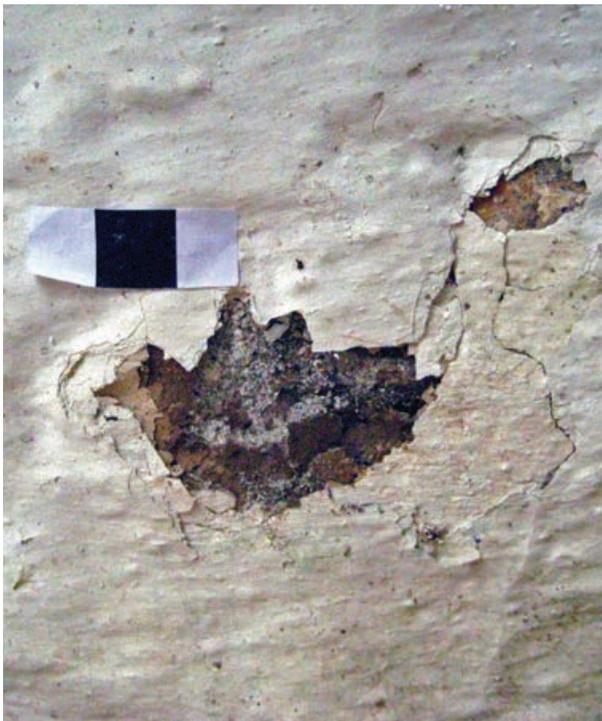
The whitewash finish revealed a few *lacunae* in the mortar system on the exterior, but this condition too appears to be isolated and easily repaired (Figure 27).

FIGURE 27 Small *lacunae* in the exterior lime finish are easily repaired. Exterior finishes are in good condition

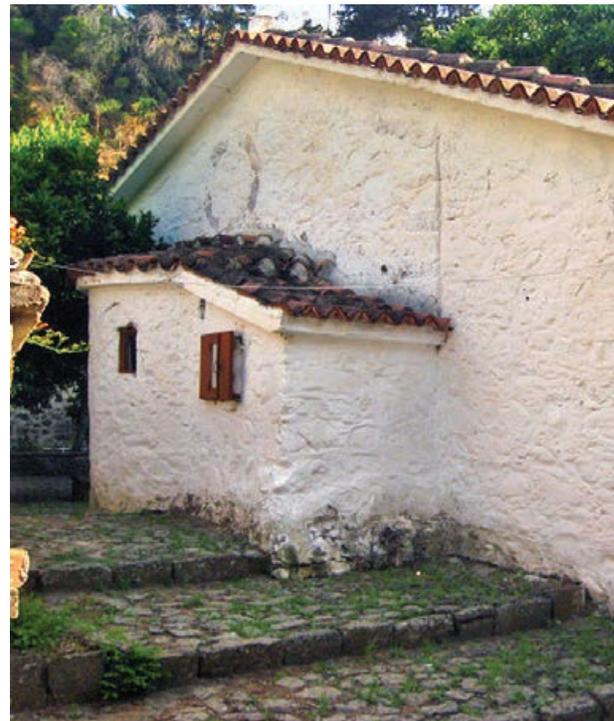
FIGURE 28 Although the interior floor level remains constant, the raising of the exterior grade at the east façade is very damaging

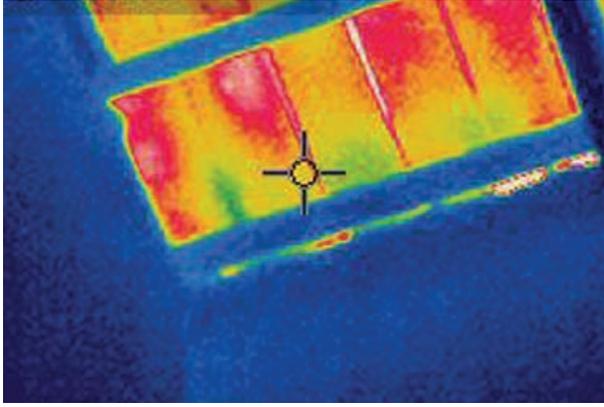
FIGURE 29 Infrared image of the top of the south wall. Note that the moisture content of the wall (blue) is quite even

upper portions of each wall revealed little or no moisture content within the upper portions of the walls (Figure 29).

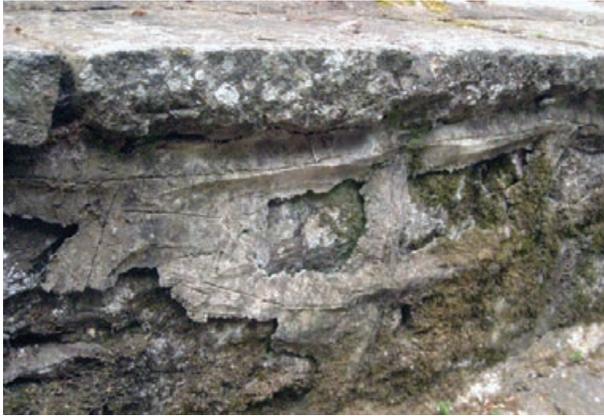
FIGURE 30 Hard hydraulic cement mortar at benches entraps water, exacerbating wall deterioration

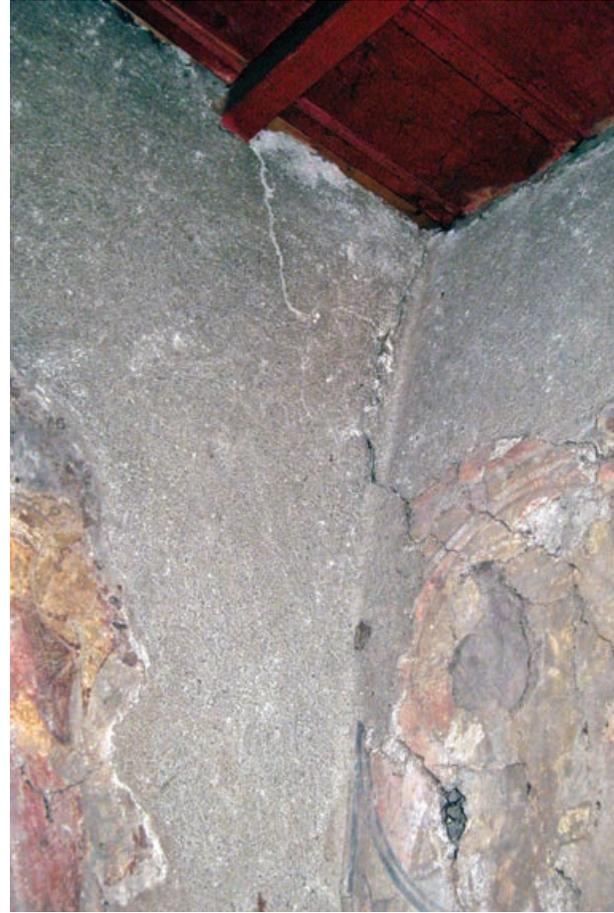
FIGURE 31 Interior wall damage resulting from previous deterioration and subsequent repairs

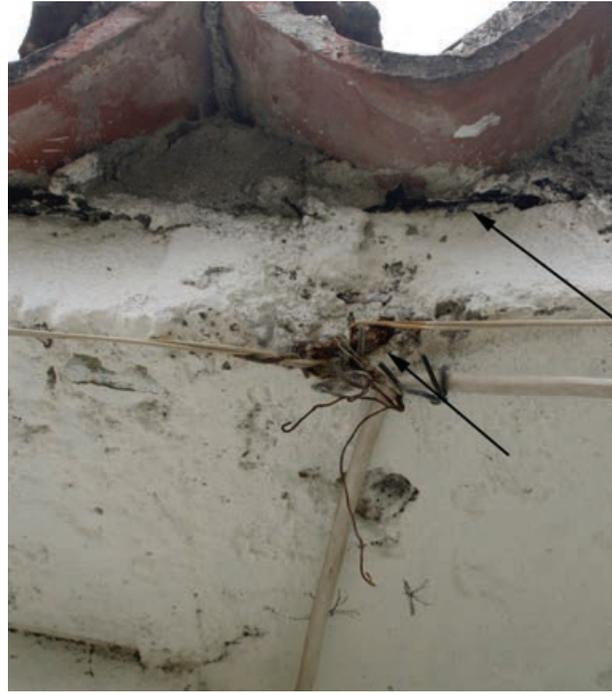
FIGURE 35 Cracking and deterioration due to rusting rebar

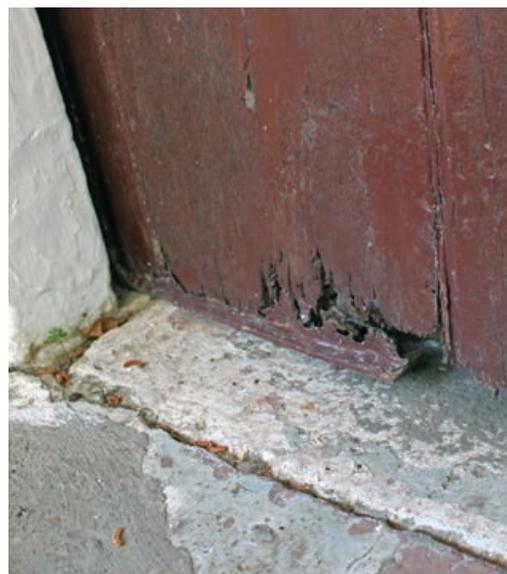
FIGURE 38 Wood deterioration from moisture at the bottom of Door D1

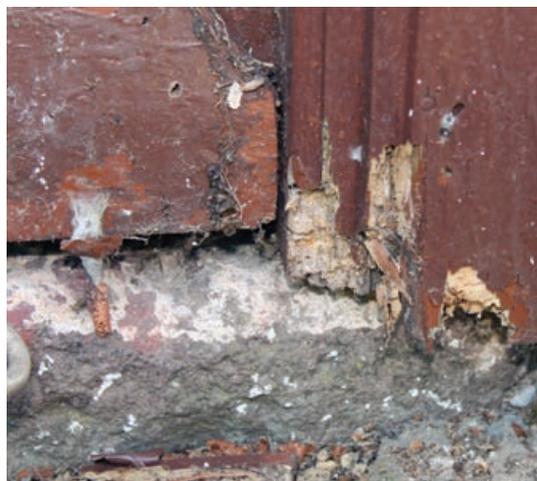
FIGURE 41 Wood deterioration at the bottom of Door D2

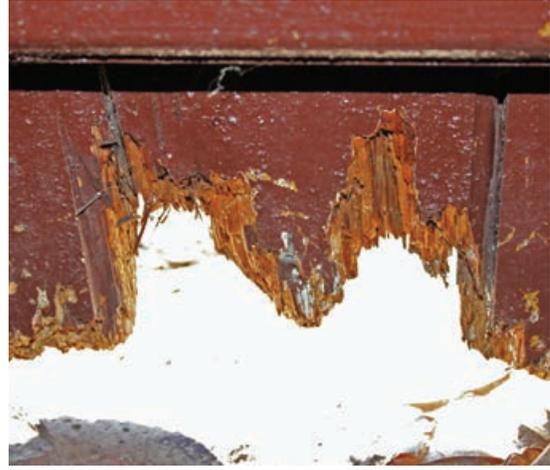
FIGURE 44 Wood deterioration at the bottom of Door D3

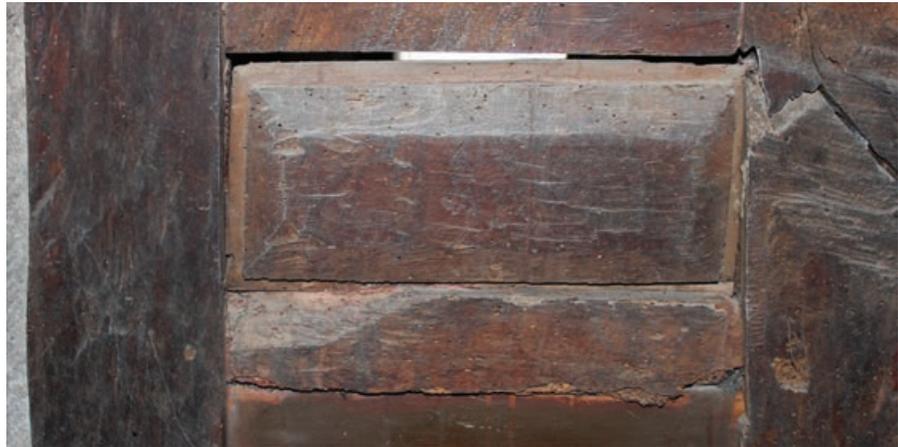
FIGURE 47 Deterioration from rotted tenons

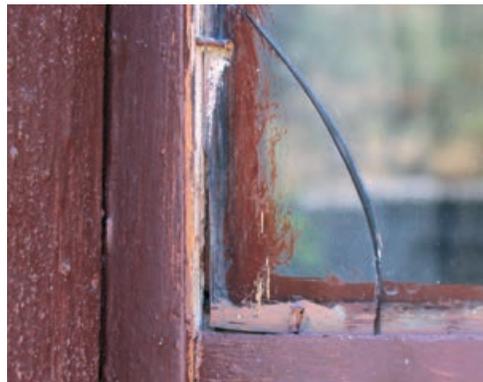
FIGURE 65 Exterior sash detail, showing missing glazing compound and cracked glass

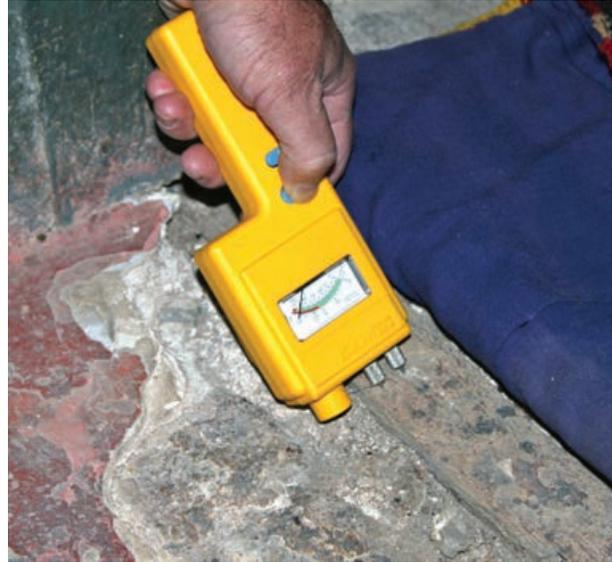
FIGURE 71 Very high moisture levels could be recorded underneath the carpet in the Sanctuary

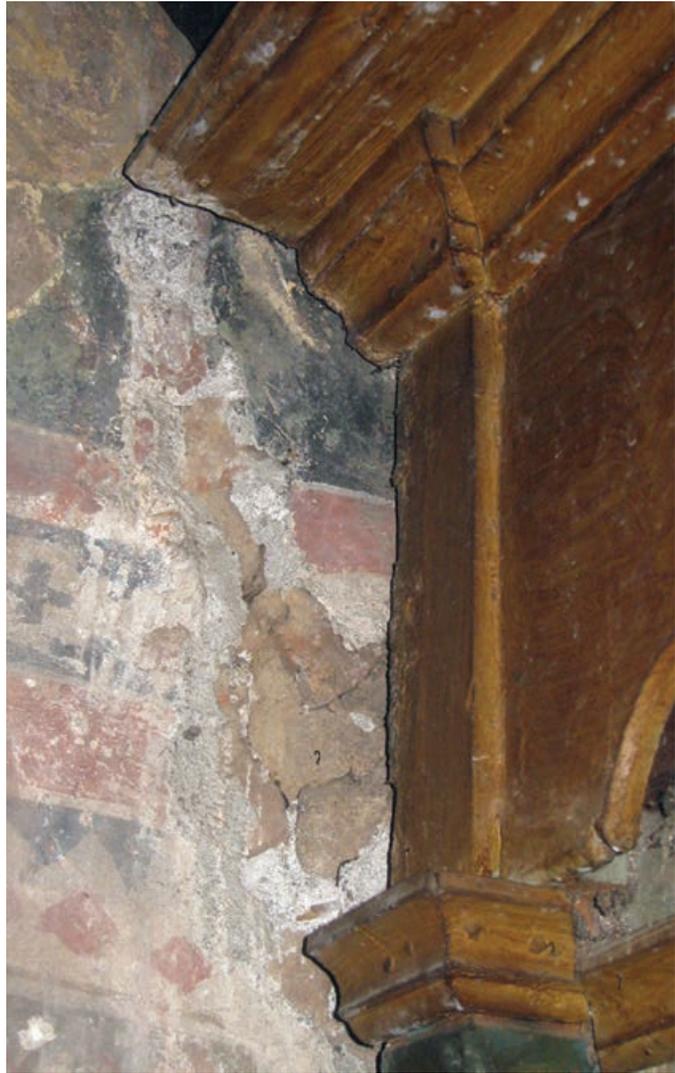
FIGURE 76 Evidence of deterioration at the cornice of the iconostasis

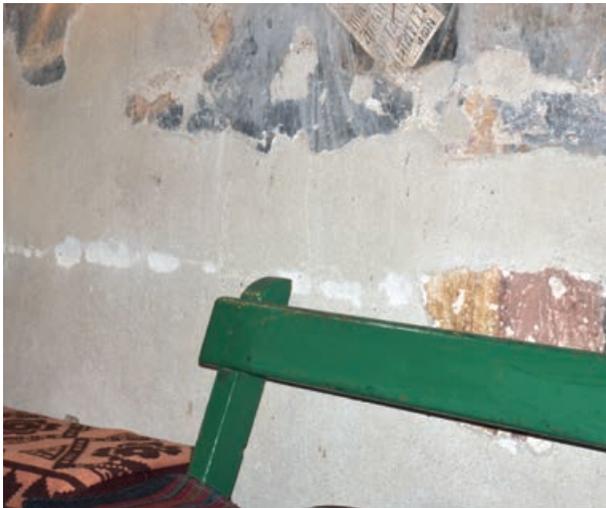
FIGURE 86 Mechanical damage to the paint and plaster on the north wall of the aisle caused by movable furniture

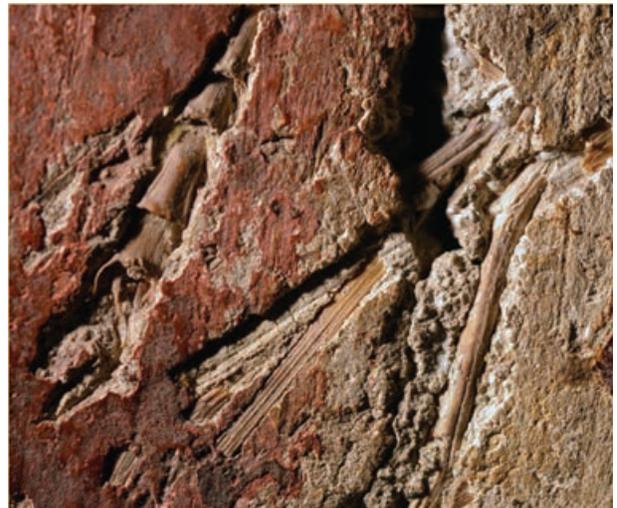
FIGURE 87 Detail of deterioration from the expansion of chaff included in the plaster

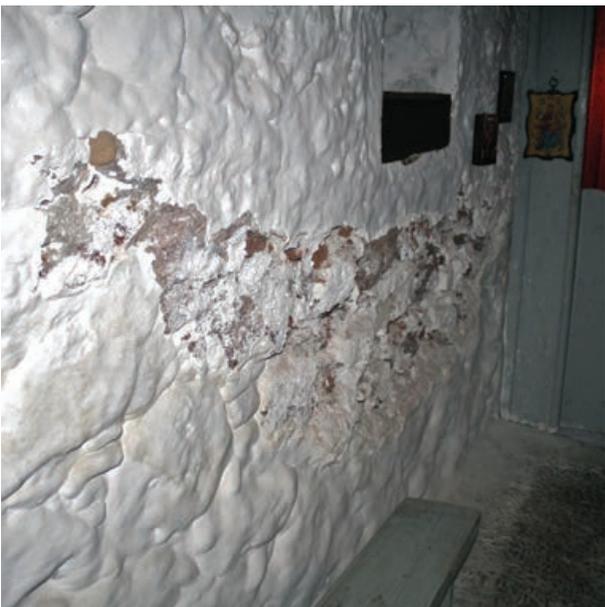
FIGURE 101 Spalling plaster on the north wall of the church

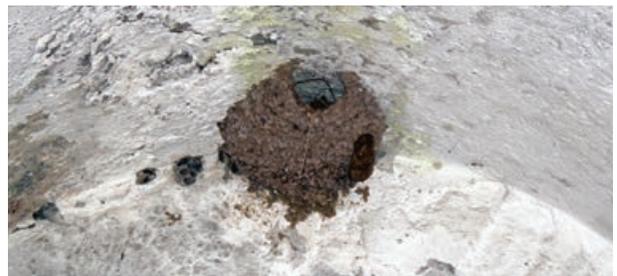
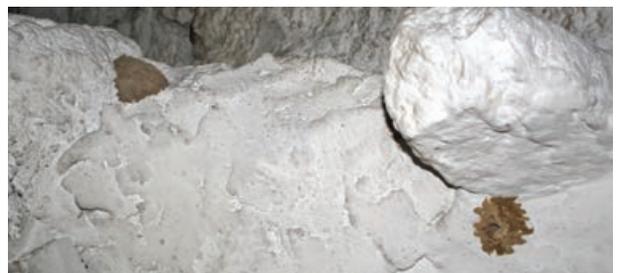
FIGURES 102, 103 Swallow and wasp nests in the interior of Agios Stephanos

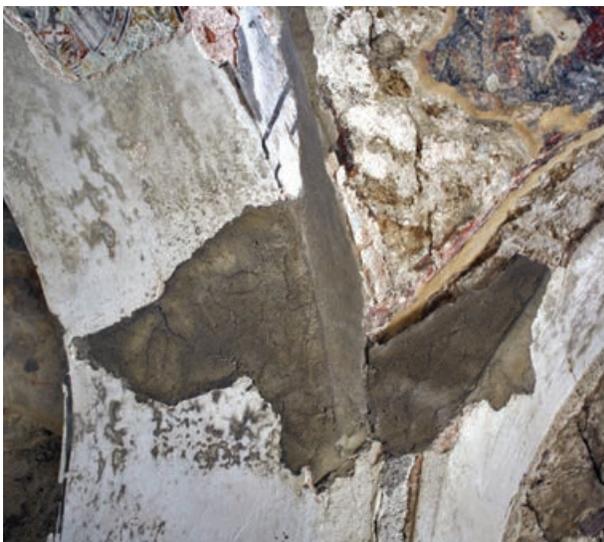
FIGURE 108 Inappropriate repairs using cement

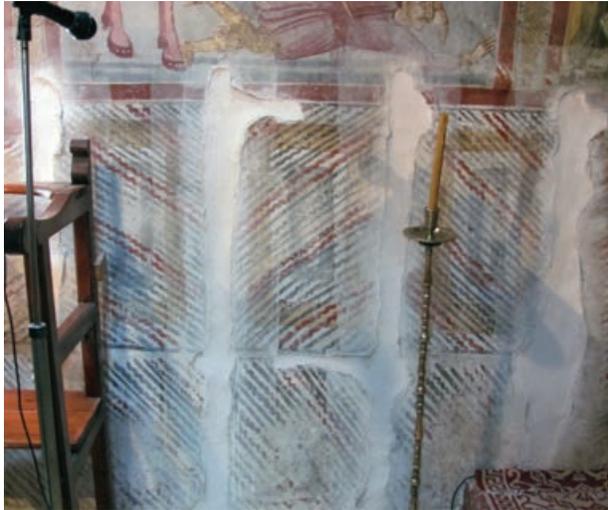
FIGURE I24 Evidence of damage from seating furniture

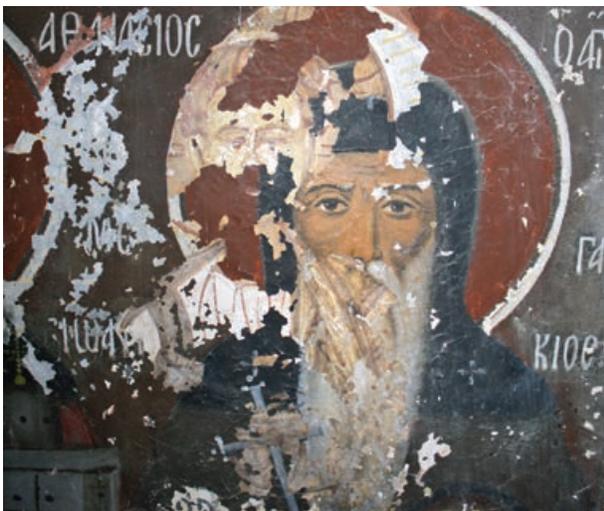
FIGURE I31 Fragments of the older layer of wall paintings have become visible at areas of deterioration

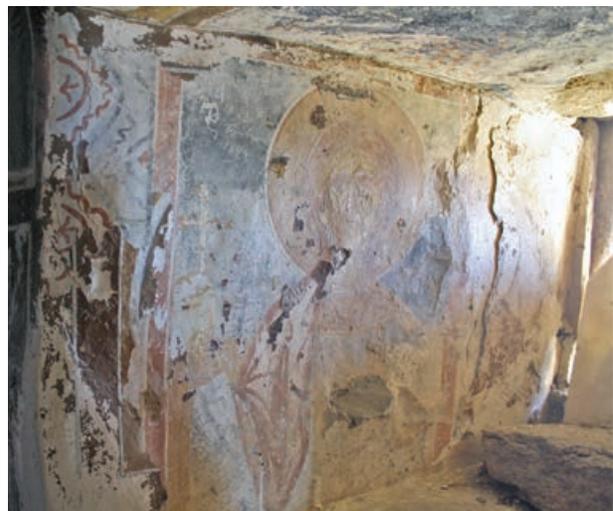
FIGURE I32 Deterioration around window opening on the south wall of the church

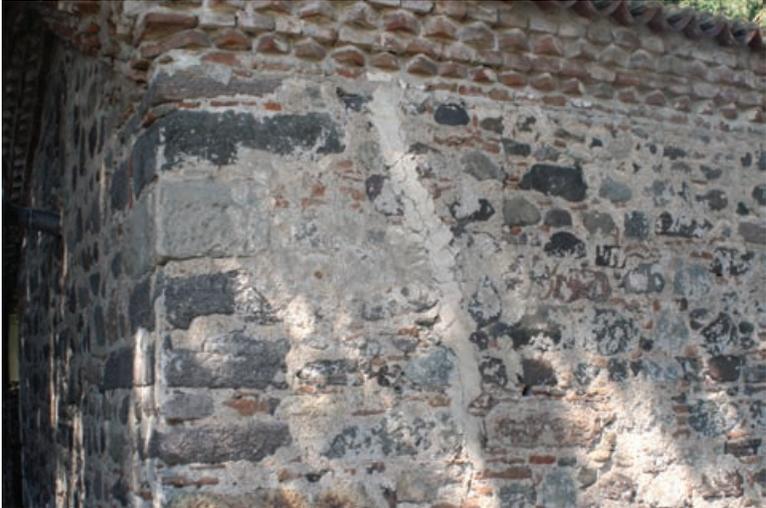
FIGURE I35 A large crack runs through the south wall

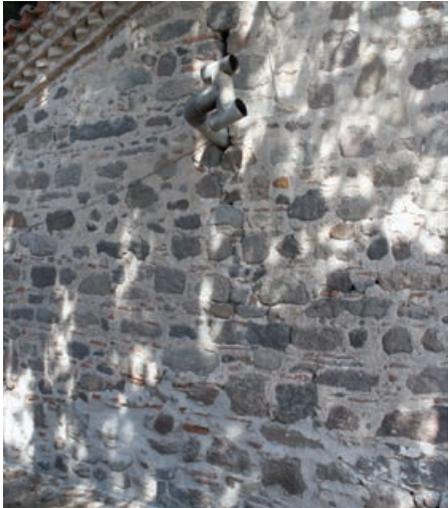
FIGURE I36 A crack can be seen on the west wall

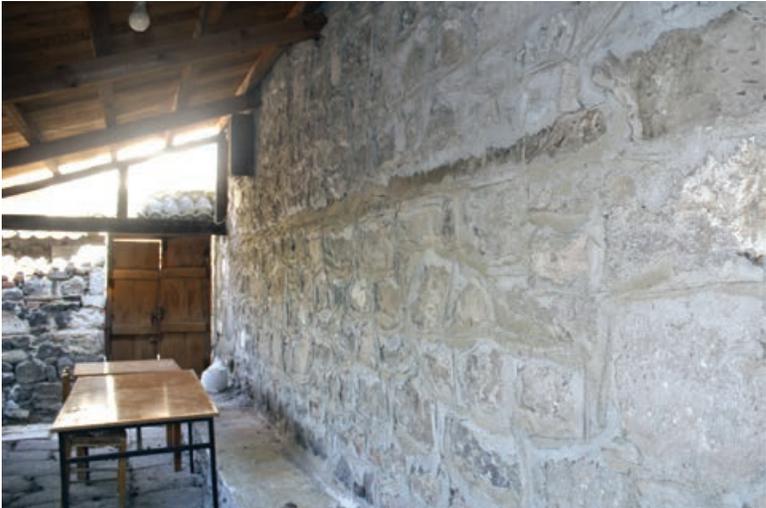
FIGURE I37 The north wall has been covered with cement mortar

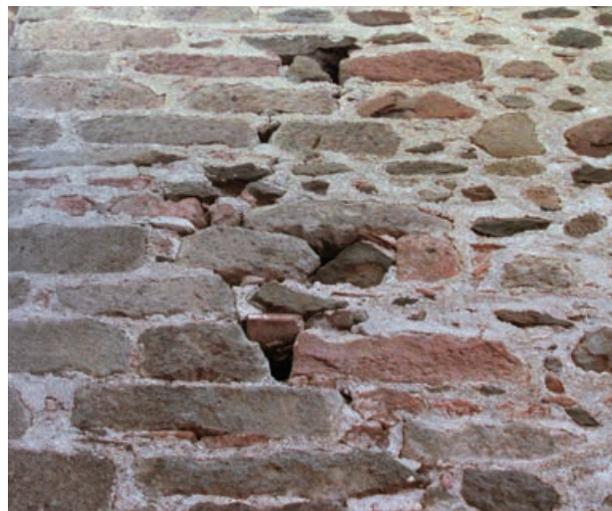
FIGURE I42 Deterioration of the exterior wall on the east façade

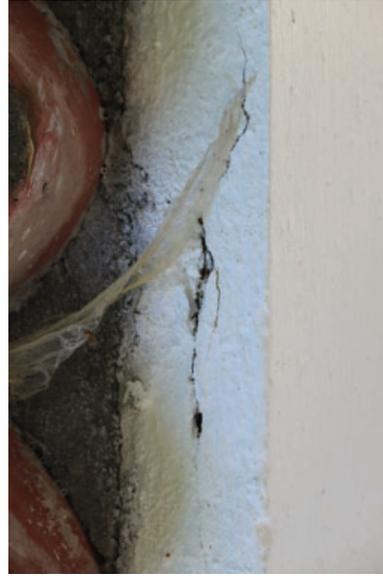
④

Rusting rebar is seen throughout the church in the soffit.

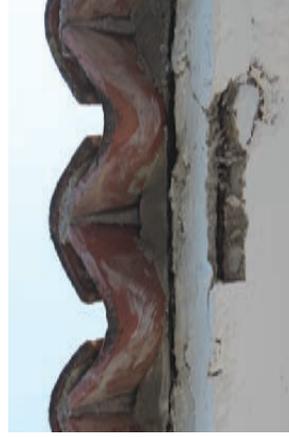
③

Surface cracking is also common at the interface between lintels or headers and the surrounding stone and mortar wall. There tends to be superficial cracks in the mortar or whitewash.

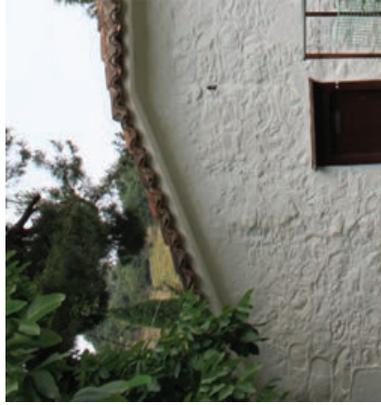
③

Portland cement-based pointing is detaching from wall surface, causing superficial cracking.

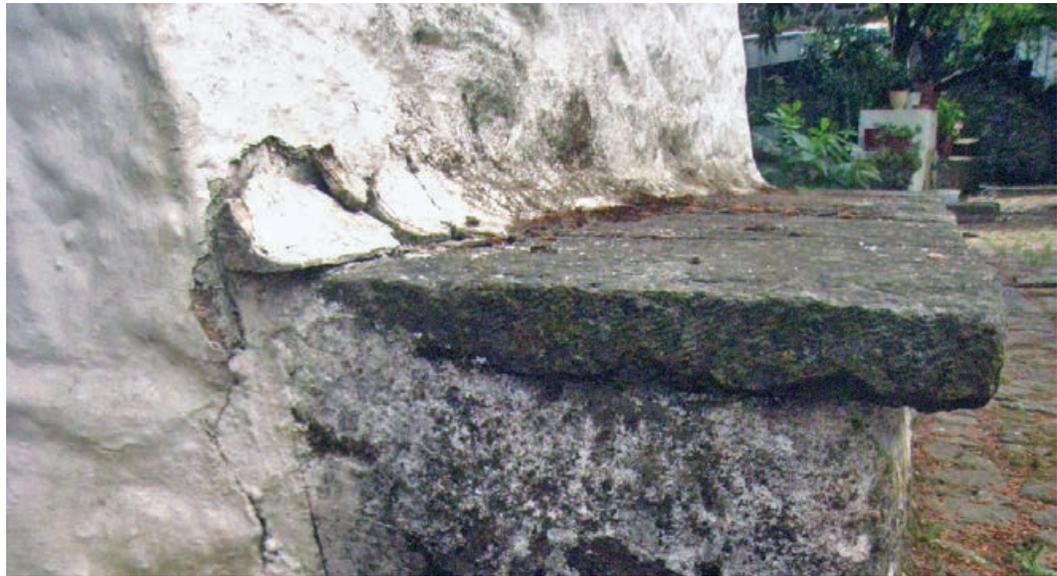
Prior to the implementation of the work, moisture meter readings were taken within the bench masonry, after removal of the seat stone. Readings were at the high end of the meter capacity.

Mock-up bench prior to the implementation of work. Note the ungainly cement cant at the rear of the seat, and biological growth.
