Churches of Lesvos

**A Preservation Study for the Katholikon
of Moni Perivolis and Other Historic Churches**

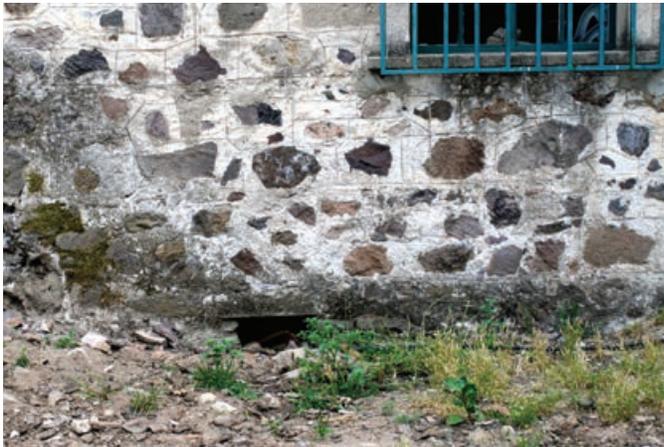
FIGURE 10 Drain on the exterior of the perimeter wall of the compound

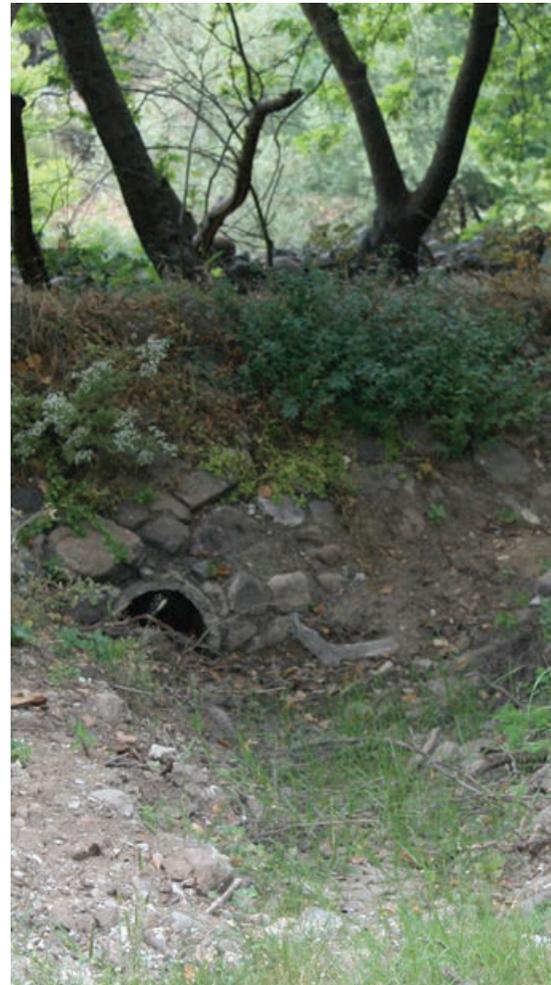
Both drains empty into the channel that runs along the exterior wall and that also serves as a drain for a spring emanating from the hillside across the driveway, as well as for water flowing along the driveway. The channel then leads to a corrugated steel pipe through a storm-berm toward the nearby Voulgaris River, near the northwest corner of the compound (Figure 12). Plant growth can be seen along the drainage channel.

FIGURE 12 The drainage channel flows through a pipe into the Voulgaris River.

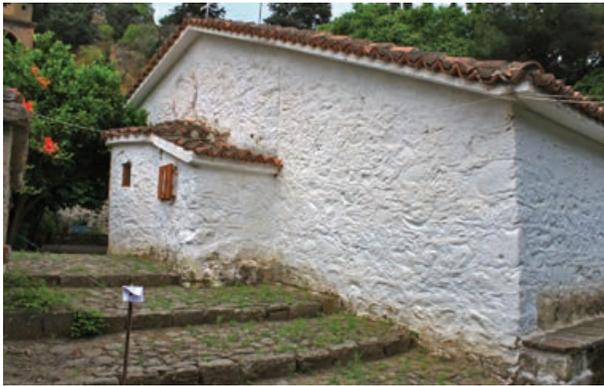
and its effects on wall paintings in the apse (Figure 13). Of additional concern are the benches attached to the exterior of the church on every side except the east (Figure 14). For more details on the effect of the benches see the section on Walls, below.

FIGURE 13 Stepped terrace at the east end of the church

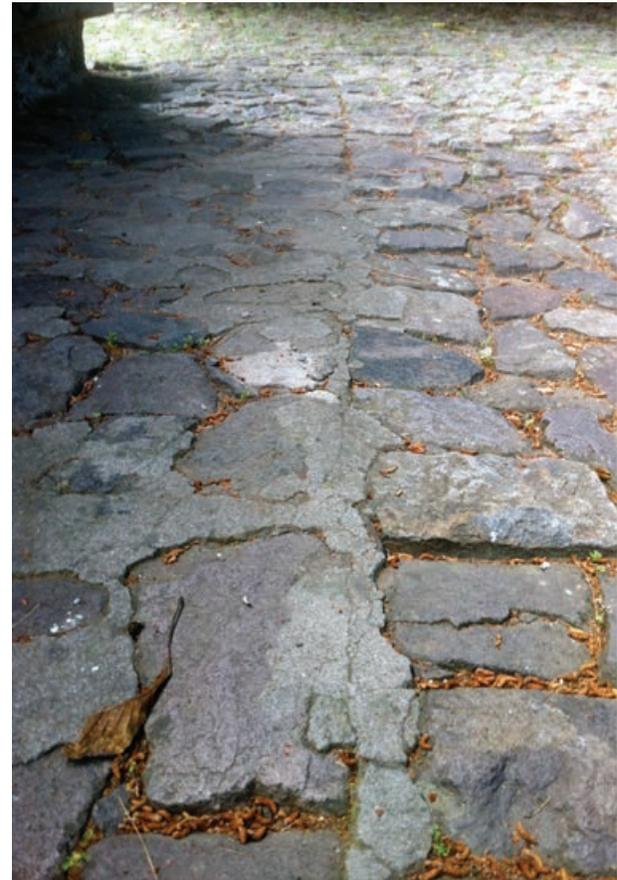
The rivulets in the paving system stones that are aligned long edge to long edge appear to be performing properly during rain events (Figure 15). One adverse condition in the drainage system is the blocking of some of the channels in front of the main entrance with a layer of hydraulic cement (Figure 16).

Although not observed during the site review, it can be reasonably hypothesized that this blockage causes water to pool at the front door at either side of the blockage, and more prevalently on the south, or uphill, side. Additional problems arise at the main and side entrances, where recently hydraulic cement slabs have been laid outside of the building. Not only do they partially block the drainage system, they are within 1 centimeter ($\frac{1}{2}$ inch) of the height of the door thresholds and finish floors of their corresponding doors, creating a path for water flow towards the interior (Figure 17).

FIGURE 16 Open joints between the stone pavers filled in with hydraulic cement

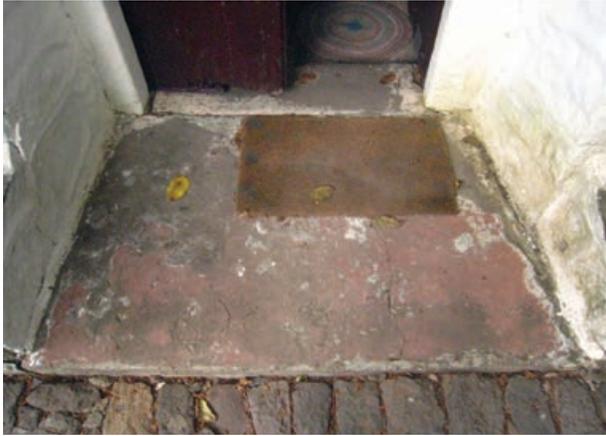
FIGURE 17 Cement slab at the threshold of the main entrance door

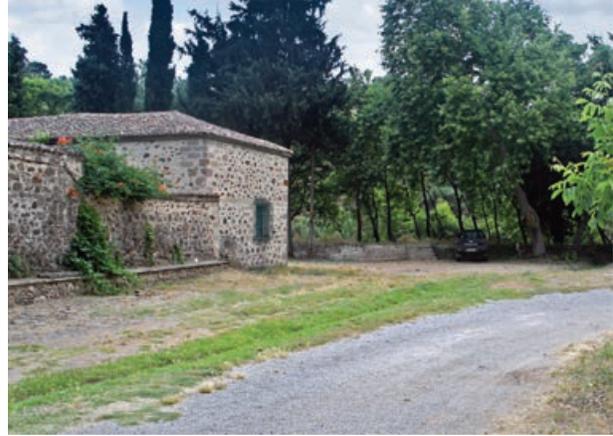
Continuing through the drainage system, the drainage channel immediately outside of the courtyard wall has been partially filled with silt and vegetation (Figure 18). These three conditions warrant remedial action to keep the system fully performing.

FIGURE 18 Plant growth in the drainage channel

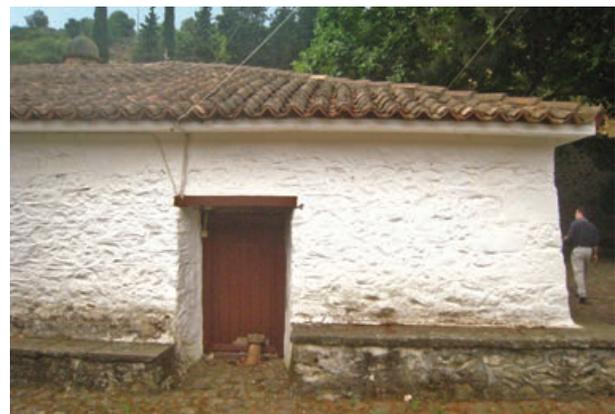
While the south and east façade walls were constructed relatively plumb, the north and west walls are “battered” on the exterior surface, a building method more typically found in dry-laid stonemasonry walls (Figure 22). Anecdotal information has suggested that the battered surface of the north and west walls is a later intervention, constructed to prevent wall collapse. This information was not confirmed by investigative probes, and this condition does not appear to affect the condition of the walls of the structure.

FIGURE 22 “Battering” of the stone masonry walls suggests dry-laid stone construction

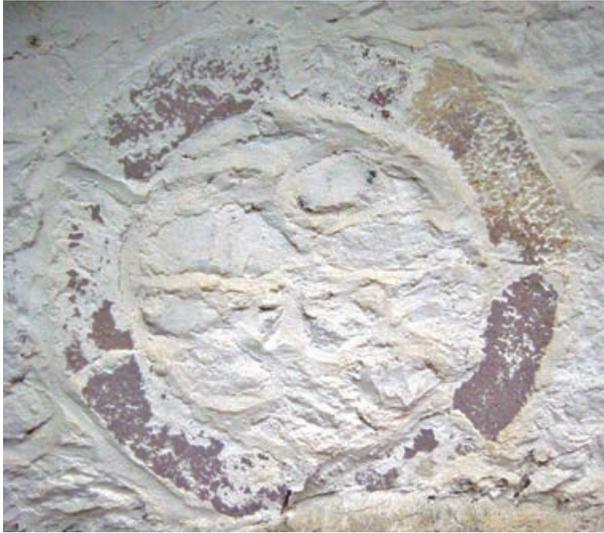
FIGURE 23 The rose window on the east façade has been filled in

Exterior walls are penetrated by four window openings: two on the south façade, one on the north façade, and one within the apse. Seven dressed segmented arch stones at the east gable end of the building just above the apse roof are likely to be the extant remains of a surround for a window opening at this location that was never installed, or was later removed and filled in (Figure 23).

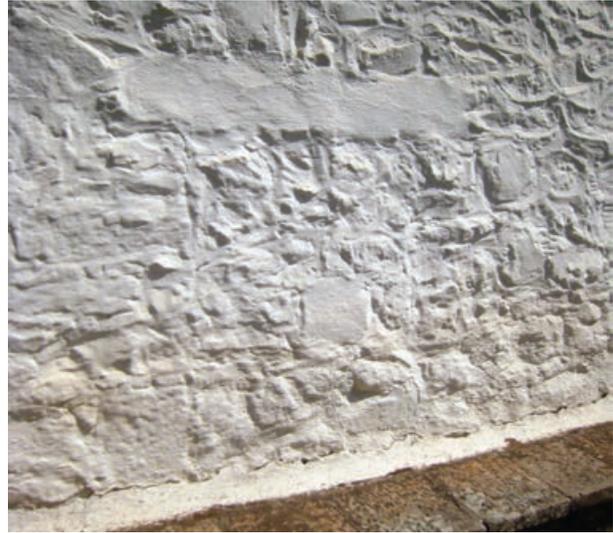
FIGURE 24 A former door opening on the south façade has been filled in

There are presently three door openings, although the ghost of a fourth former opening is visible near the west end of the nave on the south wall (Figure 24).

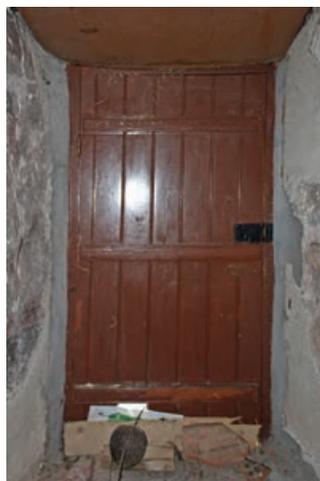
FIGURE 41 Wood deterioration at the bottom of Door D2

While the top portion of the door is sound, the lower door is in poor condition. The bottom of the door and the bottom and the underside of the door frame are rotted along a third of the door height (Figure 41). The lowest horizontal member is loosely attached and there is a large hole in the door where the bottom section of a vertical board is missing below it. The hole in the door and the moisture in the rotting wood render the interior more vulnerable to insect infestation and damage.

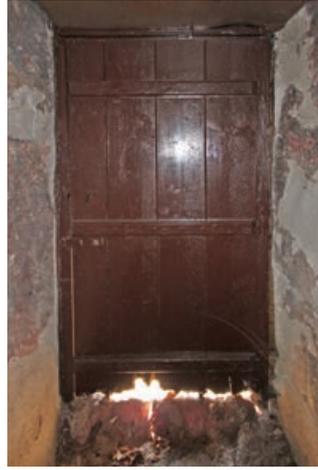
FIGURE 43 Door D3, from the interior, showing wood battens

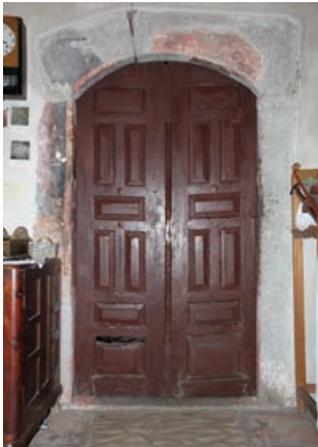
Door D4 is in a very fragile condition. The lower third of both leaves is highly deteriorated, presumably from moisture-related causes. Several panels are separating from the rails and stiles, where the tenons holding the joinery in place have rotted (Figure 47). The bottom two panels of each door are deteriorating—exhibiting severe biological deterioration—and are fully detached from the horizontal rail above. The inside faces of the doors, which are unpainted, exhibit numerous insect holes and there is frass in some places, evidence of insect infestation (Figure 48).

FIGURE 45 Interior Nave Door (Door D4), from the side of the narthex

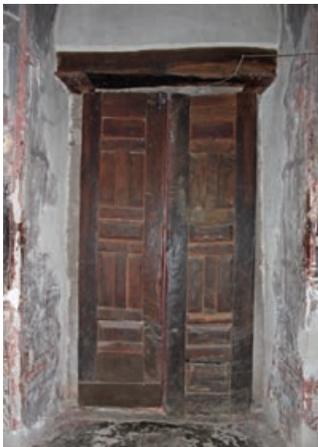
FIGURE 46 Door D4 from the interior

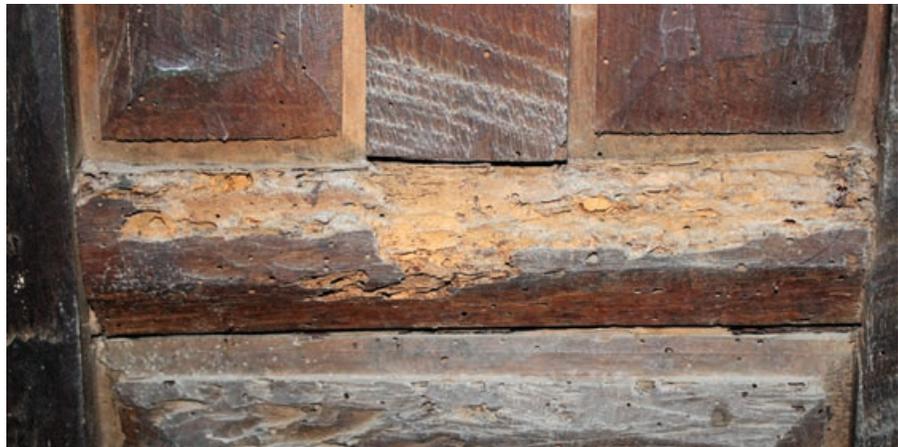
FIGURE 48 Evidence of insect infestation on the unpainted side of the door

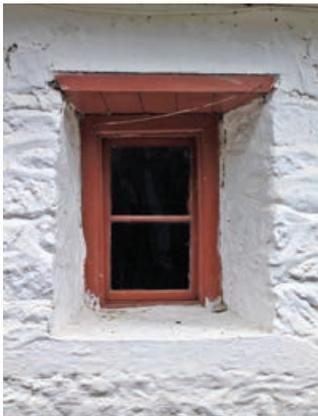
The window sash rests skewed in the opening and is not tight within the frame, creating a gap at the top left side of the window. The painted wood sash and trim are in good condition. However, there is no glazing compound on the sash, leaving the sash elements vulnerable to water or UV deterioration and the glass insecure within the sash.

FIGURE 49 Window W1, in the north wall of aisle, exterior

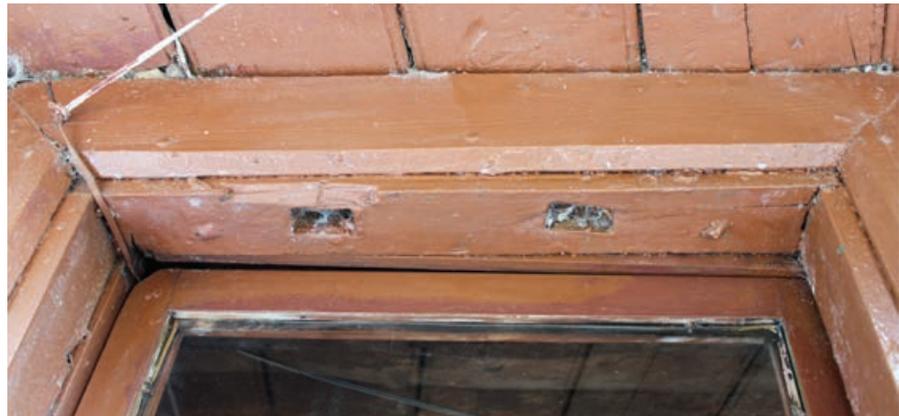
While the existing window sash and the trim are contemporary, portions of the frame appear to be older. The upper portion of the window frame retains larger, possibly hand-wrought iron fasteners (Figure 50). There are also two rectangular holes in both the top and bottom of the window frame that likely held vertical security bars in front of the sash at an earlier time.

FIGURE 50 The upper portion of the exterior window frame shows iron fasteners and rectangular holes

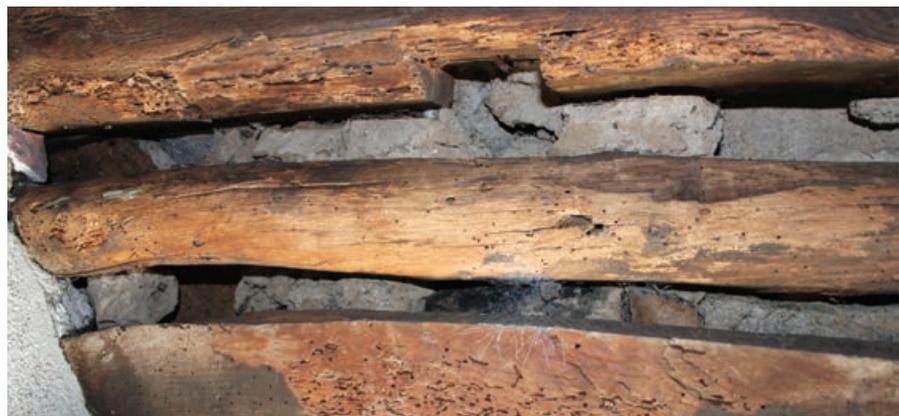
In the interior, a lintel of three wood members supports the masonry above the opening (Figure 51). The timber exhibits some evidence of insect infestation (Figure 52).

FIGURE 52 Detail of lintel showing insect flight holes

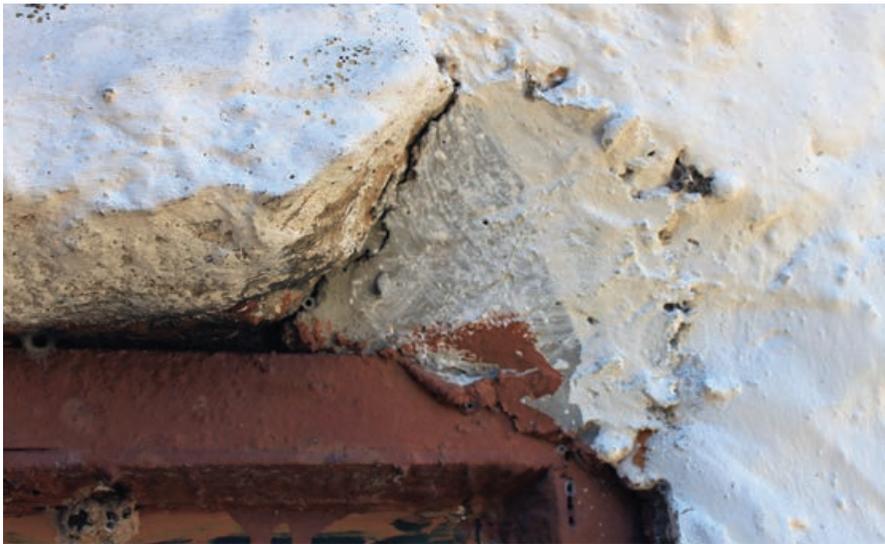
FIGURE 55 Hydraulic cement patching on the top right corner of the stone lintel

The steel sash is in good condition. The right end of the stone sill is broken. Above the sash, a large section of the stone lintel is missing on the right side and has been patched with hydraulic cement (Figure 55). Some fissures in the stone at the window head may be permitting water infiltration, and a gap between the window head and surrounding masonry is problematic.

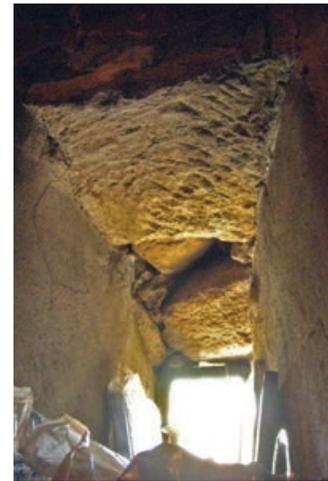
FIGURE 56 Stone lintel above the recessed window opening, view from the interior

On the interior, the window is recessed deep into the narrow wall opening. The sash is not tight in the stone opening and daylight and air are infiltrating. A large stone lintel supports the masonry above the opening and appears to be in good condition. The window is supported by two stone lintels. The lintel closest to the exterior wall is broken; the innermost lintel appears to be stable (Figure 56).

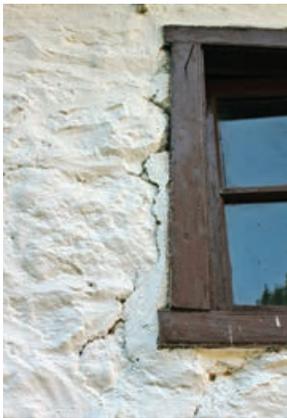
FIGURE 59 Detail of loose lime-based mortar around window trim, view from the exterior

Window W3 is in good condition, with minor exceptions. All of the wood members are sound, but the trim components and the sill are worn and separating at the joints. The trim is surrounded by a soft, lime and sand mortar that is loose and very friable (Figure 59). There is some patching with a harder, hydraulic cement mortar on the bottom left of the window trim.

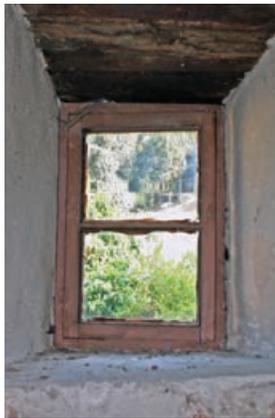
FIGURE 60 Interior sash detail

The window is inverted, with the face of the muntins that holds the glazing compound on the inside (Figure 60). There is no glazing compound on the muntins and the glass is loose within the sash. The sash retains historic “wavy” glazing, and the upper glass pane is cracked. In the interior, the wood lintel above the window opening is in good condition, with no evidence of insect infestation (Figure 61).

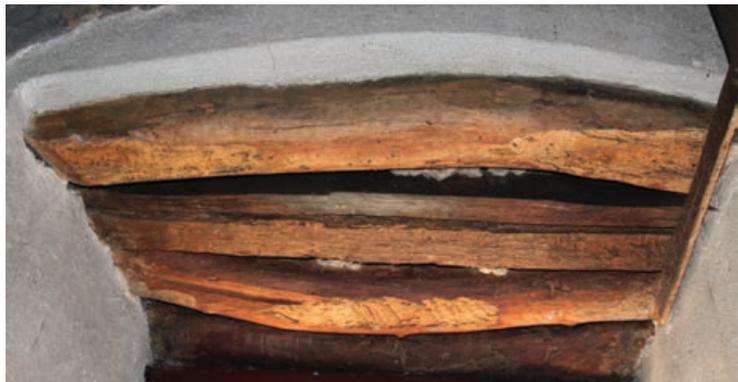
On the interior, three wooden lintel beams span the window opening (Figure 66). There are several insect holes, showing evidence of insect infestation, and frass was found on a book in the opening, showing that the insects are currently active.

FIGURE 66 Lintel, view from the interior

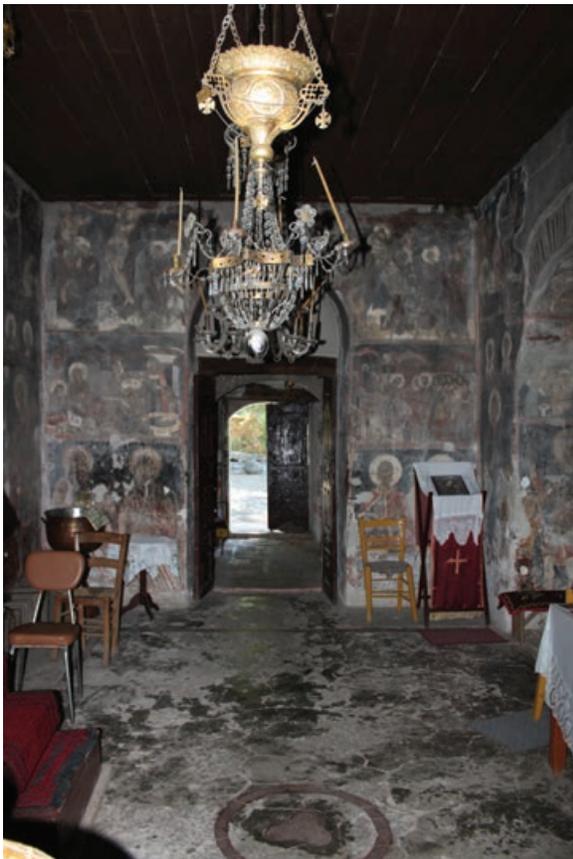
FIGURE 68 Concrete floor slab in the nave

It would be reasonable to surmise that the concrete slab in the nave contributes to rising damp in the church walls. Nevertheless, the near-complete state of preservation of the wall painting near the bottom of the south wall does not corroborate this concern.

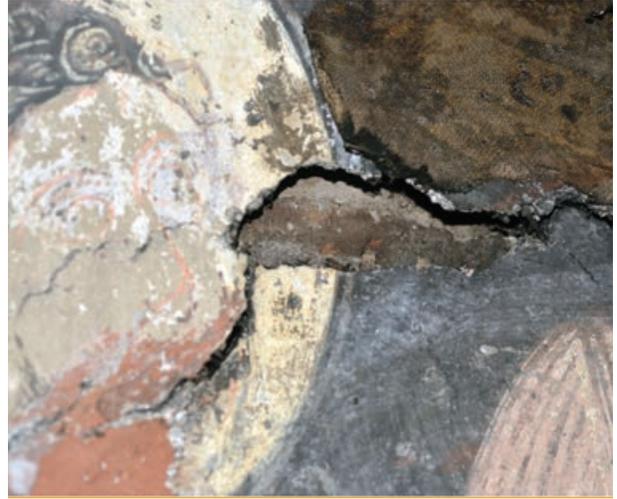
The paint layer is in variable condition, and on closer inspection various deterioration processes can be identified on many areas. The most critical problem is the lack of adhesion of the plaster in the Sanctuary (Figure 83). The severe delamination of the plaster from its support could lead to further significant loss and requires both emergency stabilization and longer-term stabilization interventions. This issue could not be investigated in 2010 because of restricted access to the Sanctuary. Permissions for conservators to undertake the work may be sought from the priest in the future.

FIGURE 83 Lack of adhesion of the plaster in the Sanctuary is the most critical problem facing the wall paintings

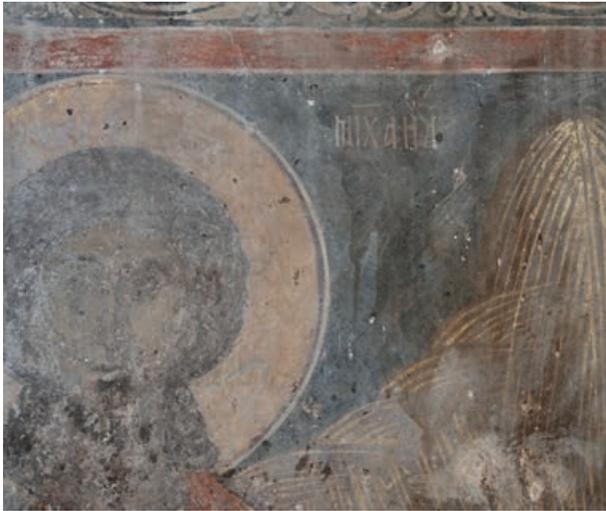
Much of the surface is affected by a whitish or grayish surface layer, which impedes the overall legibility of the wall paintings (Figure 84). It is likely for this reason that a 1994 travelogue about Moni Perivolis published in the literary journal *Nea Hestia* described the wall paintings as “ash-gray” (τεφρόφατες).¹⁶ According to some community members, the wall paintings have not been clearly visible in living memory. Analysis of samples taken in the 2010 field season indicates that this obfuscating material is not a crust but rather an organic coating. The coating contains some gypsum, but not in the form of a coherent layer or crust. It is important for this coating material, and any contaminant materials to be properly identified, and to confirm whether the samples removed in 2010 are representative of the general situation throughout the building. Nevertheless, notwithstanding the problem caused for the visibility of the wall paintings, this is not the most pressing conservation issue at Moni Perivolis, as described in the previous paragraph.

FIGURE 84 A surface layer covers and obscures the wall paintings, seen here on a detail of the figure of Archangel Michael, on the south wall of the nave

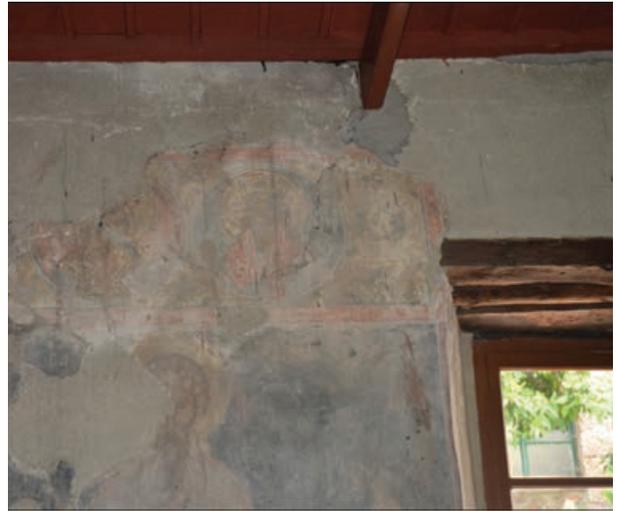
Significant areas of the original plaster and wall painting are lost on the upper registers of the aisle, on the north and east walls (Figure 85). This appears to be a result of alterations or the replacement of the aisle roof. There is ongoing mechanical damage to the paint and plaster caused by the back-rests of benches and chairs, especially along the east-west walls in the nave and aisle. These have been repeatedly pushed up against the walls and have caused damage by mechanical scraping (Figure 86).

FIGURE 85 Much of the original plaster has been lost on the upper registers of the north wall of the aisle. Paint drips from painting the ceiling can be seen on the wall paintings

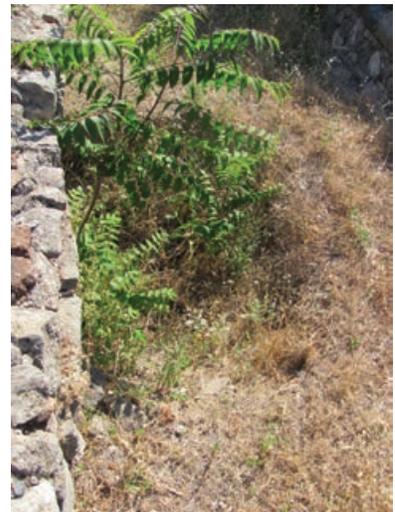
FIGURE 92 Trenches on site adjacent to existing nave walls that retain water

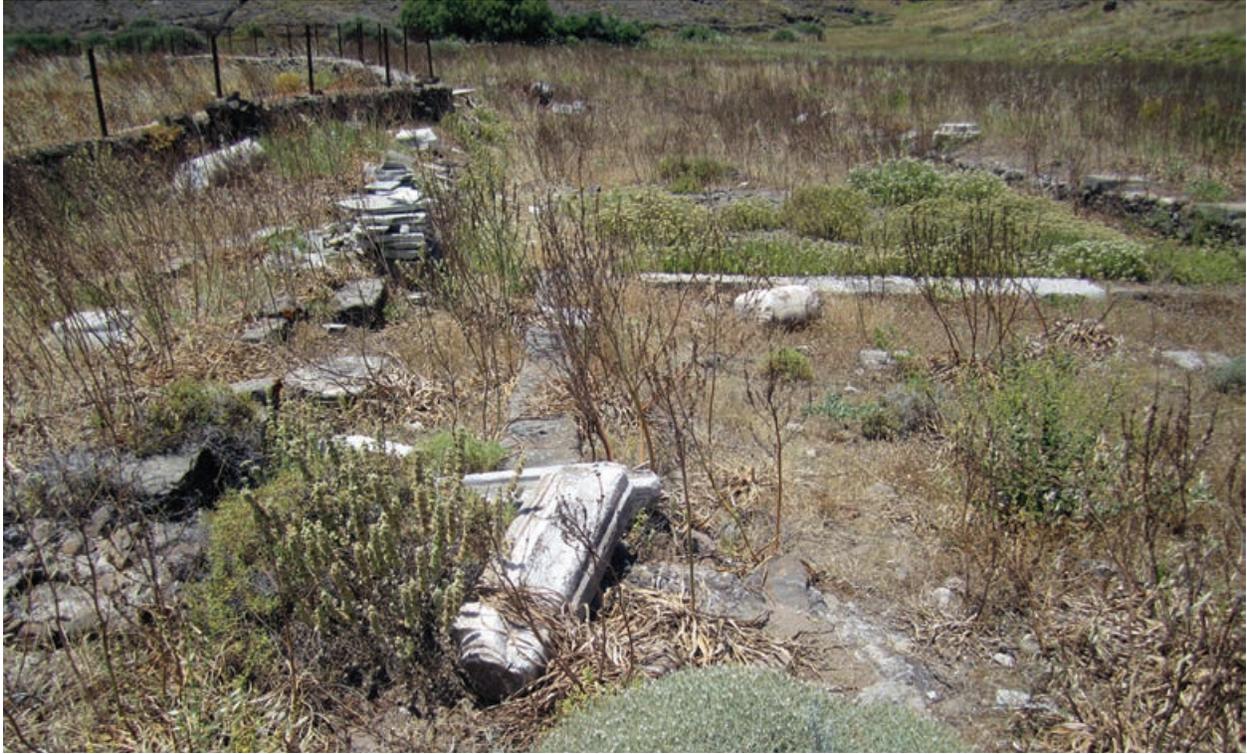
The site has yielded important archaeological information, but it is today overgrown since the last field campaign (Figure 94). Previous work at this site has concentrated on the safeguarding and conservation of the highly significant mosaic.

FIGURE 94 Overgrowth at the site surrounding the architectural fragments

Reburial or construction of a shelter have been proposed for this site. Both options will require technical expertise and material resources, and will need to be properly evaluated and designed.

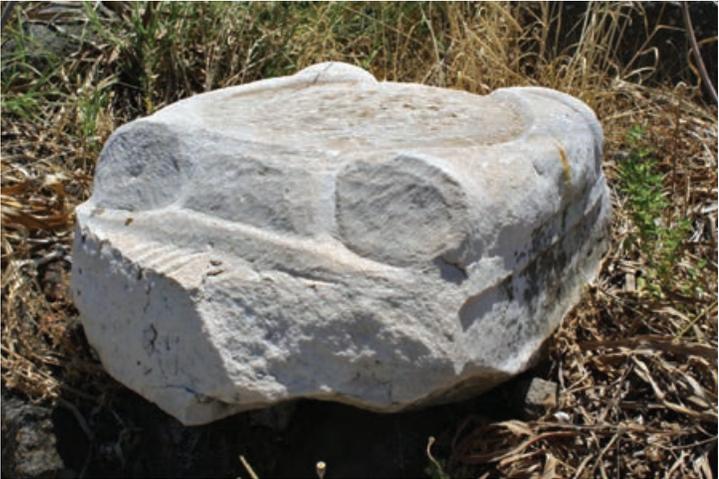
Exposure of the site to the elements is taking a toll on the remaining fragments. Marble pieces are deteriorating from exposure to airborne acidity (Figure 95). Some stones have become colonized by lichen (Figure 96). The metabolic processes of lichen produce acidic substances that break down the marble matrix, leaving the crystalline structure friable. Lastly, the architectural fragments are protected from the access road only by a low chain-link fence and face the risk of vandalism and theft.

FIGURE 95 Marble block showing erosion and rounding

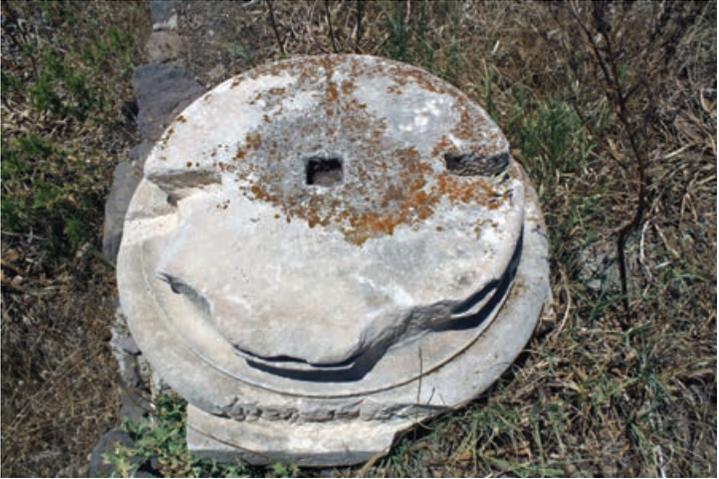
FIGURE 96 Marble column base with lichen growth

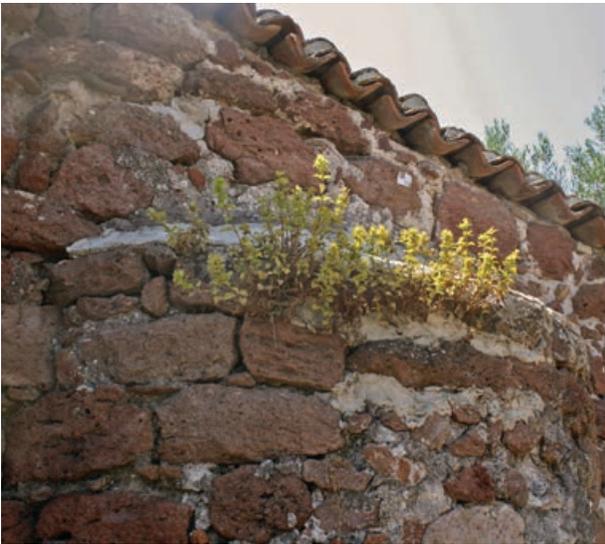
FIGURE 99 Plant growing on the north apse of the triconch

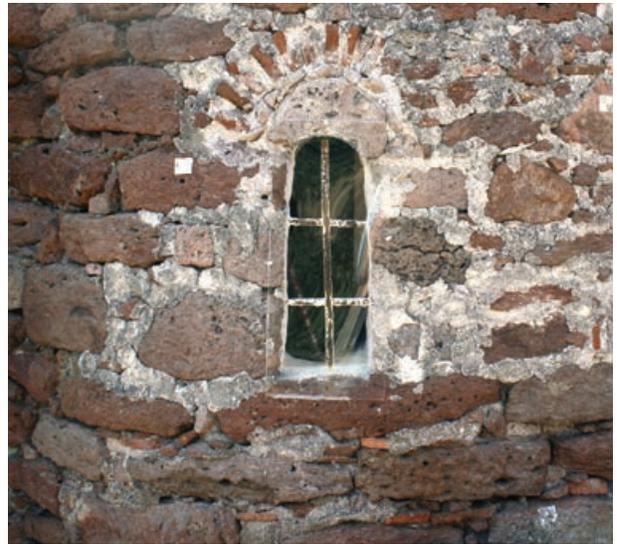
Located at an exposed coastal site in the North Aegean, the church has always been threatened by the elements. Today, the church has lost its exterior plaster finish, evidence of which can still be seen on the west façade, which is better protected by the porch. The loss of exterior plaster has revealed the underlying masonry structure and exposed the binding mortar, which has suffered considerable erosion. Some voids and cracks can be detected on the exterior, and the 2010 study recommends repairing them locally and also stabilizing the walls through mortar injection. Plant growth on the exterior also now threatens the building, since the roots of plants can widen joints and fracture masonry (Figure 99). To protect the openings of the church, Plexiglas has been installed over the unglazed and unshuttered windows of the triconch (Figure 100).

FIGURE 100 Plexiglas installed over unglazed window

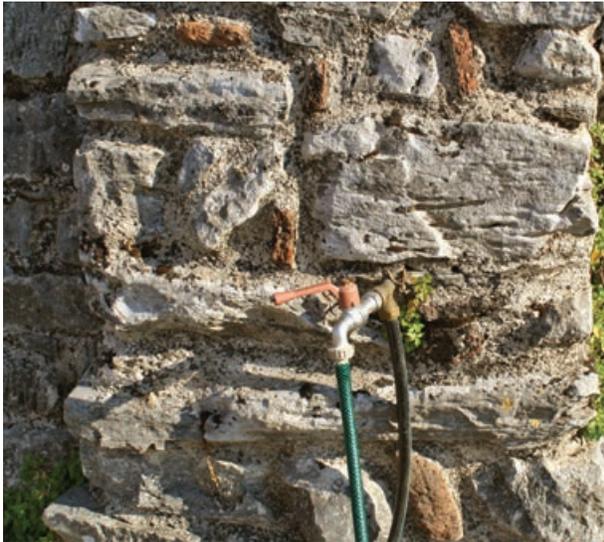
Today, the exterior walls are in very good condition, even though the church was reported to be in a poor condition in recent years. A possible cause of interior degradation is suggested by substantial cracks that can be seen in the interior, but have been repaired on the exterior, indicating a past means of water ingress. Other moisture-related problems may originate from landscaping around the church, which is watered from a hose that is directly attached to the building (Figure 106).

FIGURE 106 A spigot is attached to the exterior

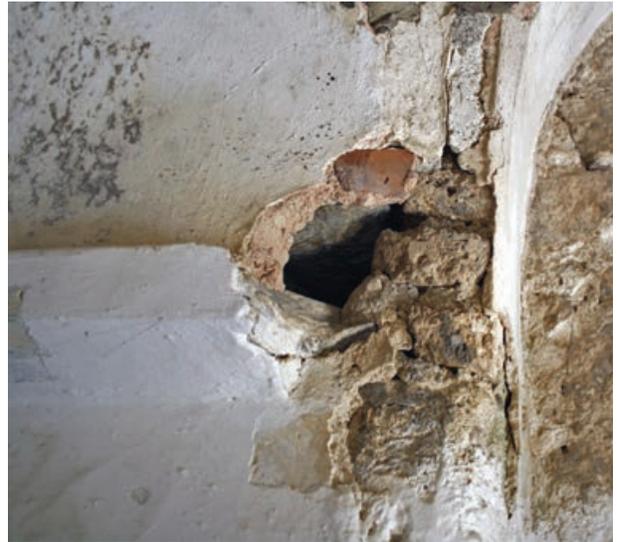
Nevertheless, there are interior conditions in need of attention. This can be partly attributed to previous interventions. Some of the major issues include unrepaired voids in the masonry (Figure 107) and hydraulic cement patches (Figure 108), which should be appropriately repaired. The wall paintings have also suffered greatly, and stabilizing facings applied to them have not been removed (Figure 109).

FIGURE 107 Void in the masonry

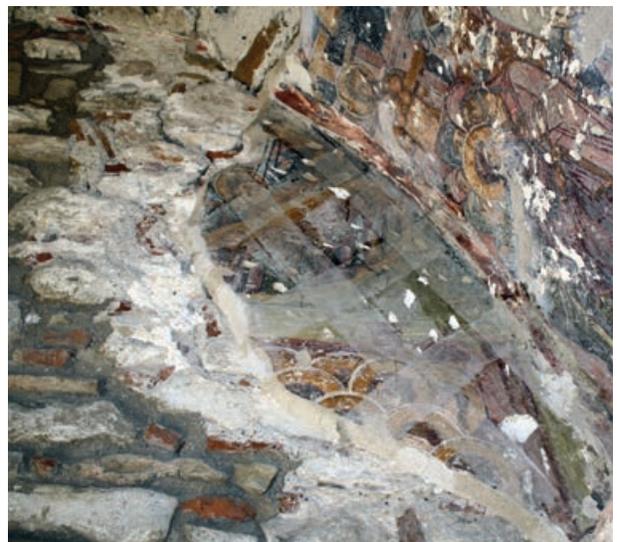
FIGURE 109 Wall paintings stabilized using fabric

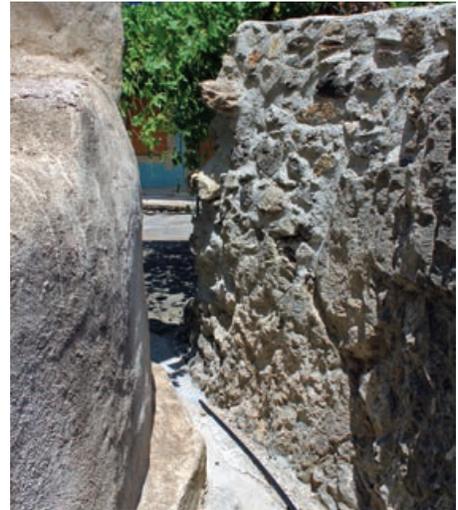
During the recent restoration a trench was dug around the perimeter of the east end of the church, creating a physical separation between the church and the hillside (Figure 113). Prior to this intervention, seepage from a spring in the inclined hillside created a severe moisture problem in the interior of the church. Now, a perimeter channel allows water to drain properly and the walls to dry thoroughly.

FIGURE 113 Separation trench between the east side of the church and the adjacent hillside

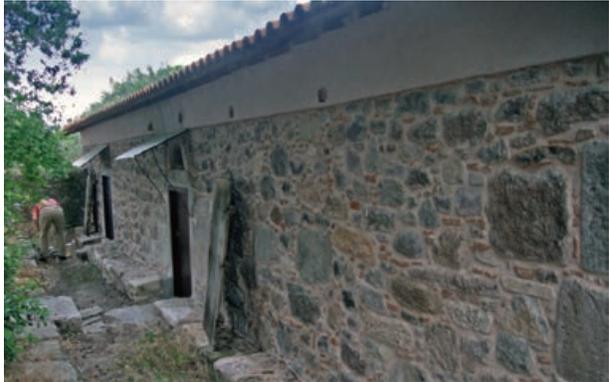
Not all of these recent interventions are successful. The roof was replaced using modern terra-cotta tiles, but without adding a waterproof membrane. Modern wooden doors with shiny new hardware were substituted for the original doors. The new doors are incompatible with the aesthetic of the historic exterior. The old olive wood doors are leaning against an exterior wall, uncovered and unprotected. Repair patches have been applied to the façade masonry using hydraulic cement, most problematically at the entrance. In addition, issues of maintenance warrant action. In the sunken walkway surrounding the church, for example, leaves and other debris are collected that can potentially contribute to water retention on the site (Figure 119).

FIGURE 119 Leaves in the sunken walkway contribute to water retention near the church

It is highly recommended to remove the hydraulic cement and replace it with traditional materials. A waterproof membrane should be added to the roof, and, when possible, the roof tiles should be replaced with a more historically accurate kind, of appropriate size and shape. The sunken walkway around the church should always be kept clear of debris. Lastly, the recently removed doors should be stored properly as evidence of traditional craftsmanship and of the history of the building.

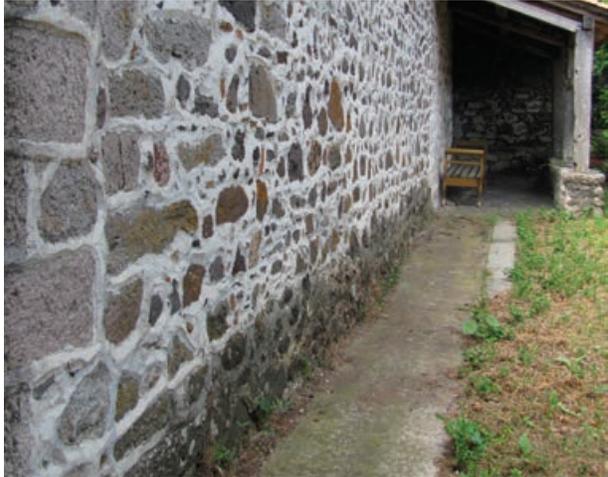
FIGURE I22 A concrete walkway surrounds the building

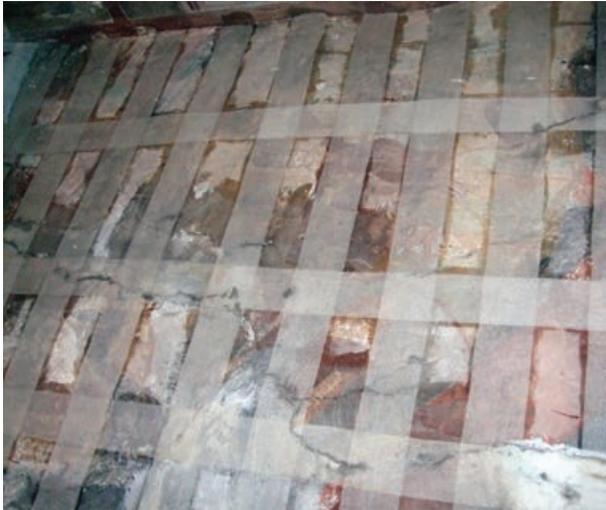
The paintings in the Agios Georgios Church are obscured by a “milky” veil that creates a similar effect to that seen at Moni Perivolis. Strips of fabric have been widely employed as a temporary stabilization method (Figure 123). As at Moni Perivolis and other sites that were visited, the wall paintings have been damaged over time by abrasion from seating furniture (Figure 124). Deterioration was partly allowed for at Agios Georgios by way of a tall non-figural zone painted to imitate marble cladding, but today this zone should also be protected. Today the north and south walls are lined with newer stalls, which again threaten this zone. The stalls should be positioned at a distance from the wall, as they have been at the Katholikon of Moni Damandriou.

FIGURE I23 Strips of fabric are used to stabilize the wall paintings

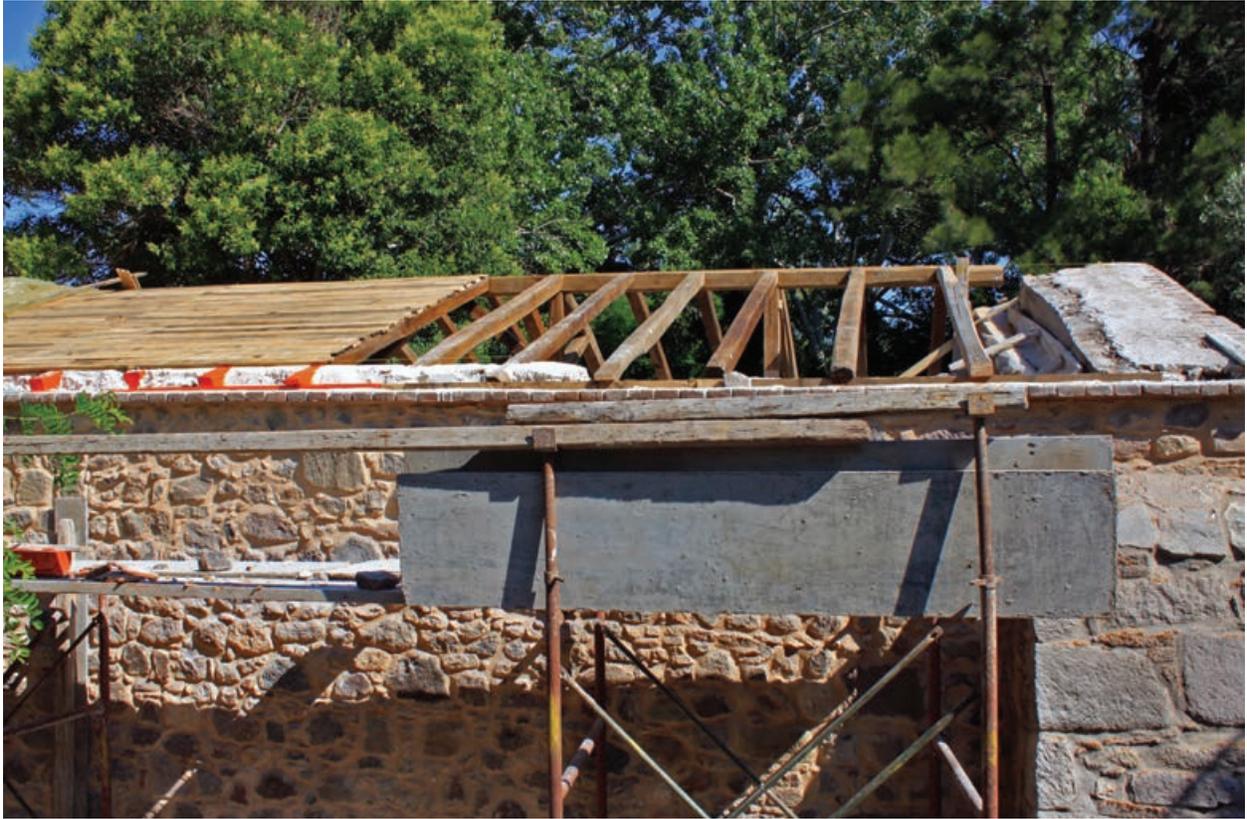
The Agios Nikolaos Church in Petra is a low-rise building with a single nave. It rests on a site that is sunken below the surrounding churchyard. The main entrance is on the west façade, slightly off center, with two arched window openings in the gable above. In the last few years the church has been under restoration (Figure 125). The stone masonry of the exterior was repointed using a lime-based mortar with brick dust inclusions. In June 2011, work was underway to replace the roof. The roof tiles had been removed and deteriorated timber rafters and decking planks had been replaced (Figure 126). The original brick soffit will be retained (Figure 127).

FIGURE I26 New timber rafters at Agios Nikolaos Church

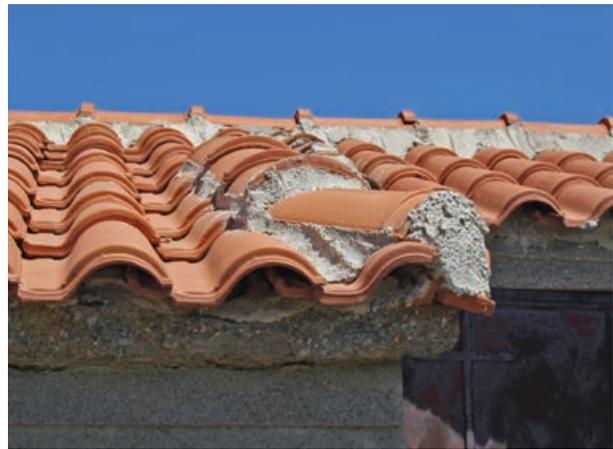
FIGURE I30 Modern tiles detract from the appearance of the building

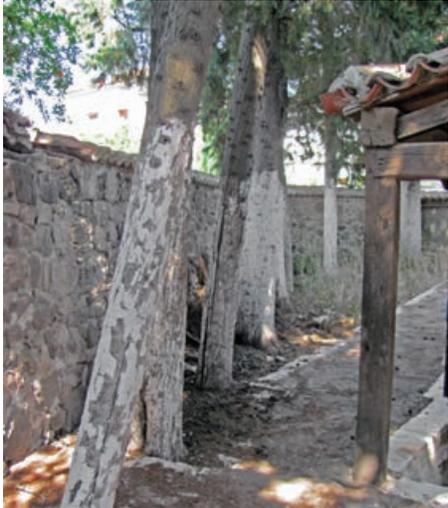
FIGURE I34 A row of cypress trees in the courtyard of the Agios Ioannis Church

Much of the wood in the interior has been damaged by moisture. For example, the dropped ceiling is rotted at several locations. In addition, rising damp has caused wooden pieces at the bottom of the iconostasis to rot, and some moldings have been lost entirely. Apparent in most of the wood members in Agios Ioannis, the moisture has been conducive to insect infestation. For the iconostasis, it is recommended that the rotted wood at the bottom be replaced and that metal flashing be installed to prevent rising damp. The moisture problem is exacerbated by the presence of numerous cypress trees planted in the 1970s on the north side of the church. According to the caretaker, the roof of the church has been replaced twice within the last 15 years, each time necessitated by rotted wood elements. Evidence of biological growth in several areas of the roof is indicative of the continued presence of moisture. It is recommended that the trees in the courtyard be removed.

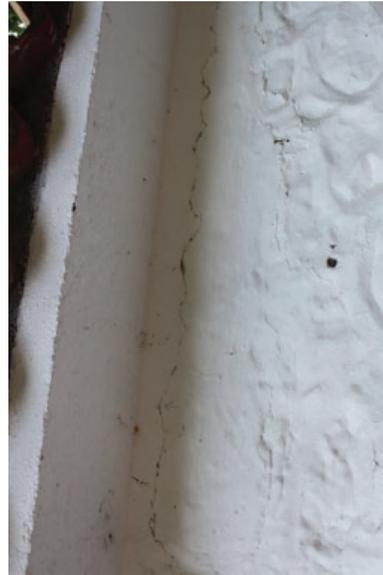
①

A separation crack between the concrete soffit of the new roof and the older wall. This general condition is found throughout the church.

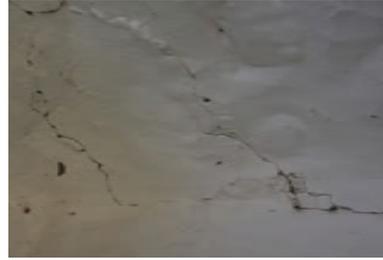
②

Surface cracking between whitewash and pointing.

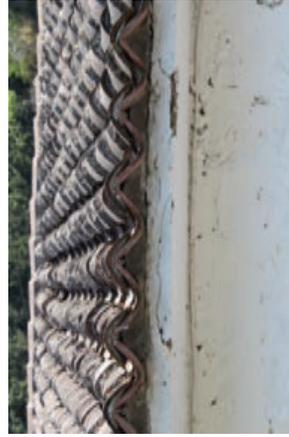
①

While the rebar in the concrete soffit is causing cracking and spalling, the roof tiles can be observed to be in generally good condition.

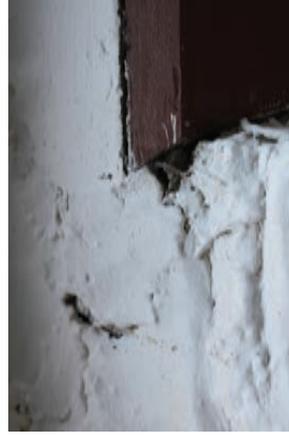
②

Surface cracking is also common at the interface between lintels or headers and the surrounding stone and mortar wall. There tends to be superficial cracks in the mortar or whitewash.

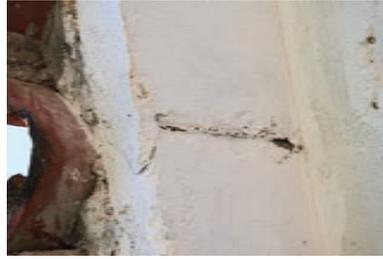
②

This clearly indicates the relation between shallow rebar and the cracks through the concrete soffit.

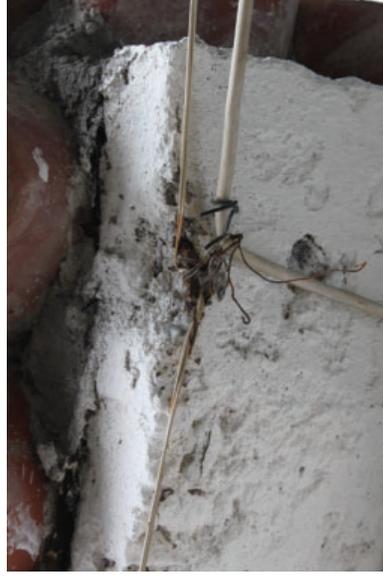
③

Utilizing the rusted rebar only exacerbates the deteriorating situation.

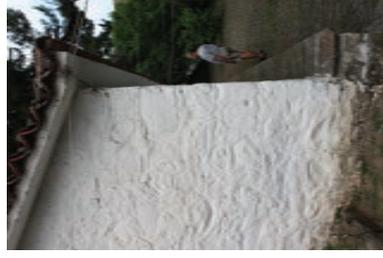
④

Both corners of the east wall exhibit cracks that could be caused by differential settling.

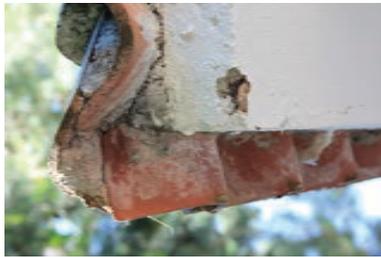
①

Rebar placed close to the surface has oxidized and is causing spalling.

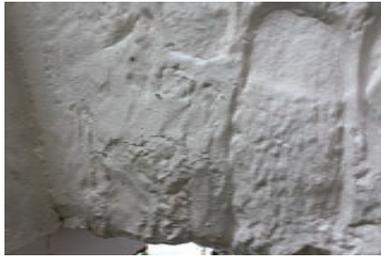
②

Portland cement-based pointing is detaching from wall surface, causing superficial cracking.

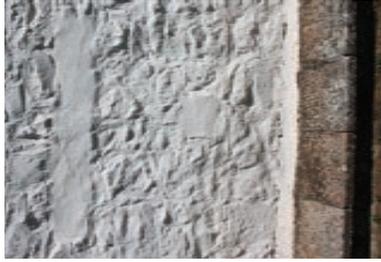
④

An earlier entrance is visible. The joints and header are possible sources of water intrusion.

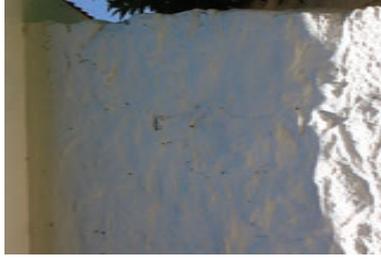
⑤

A deep crack may indicate differential settling of the apse.

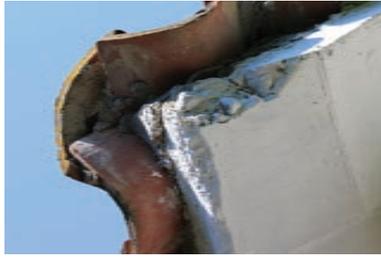
⑥

Additional rusting and spalling is evident.

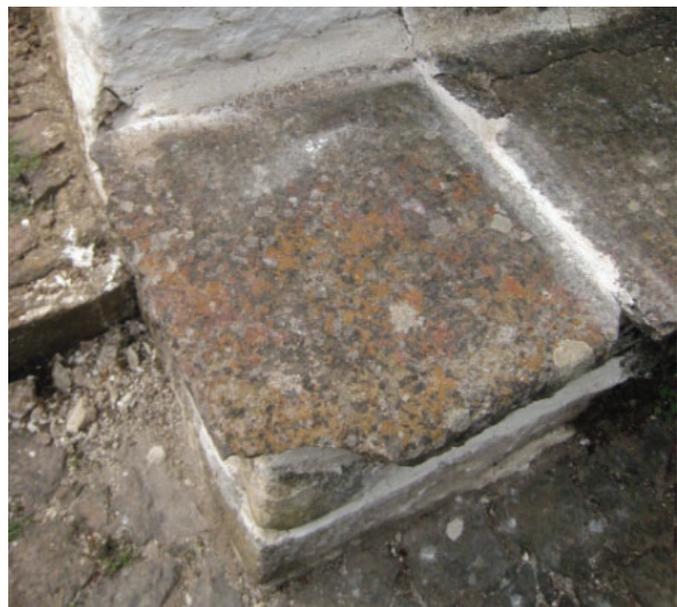
Completed repointing with reduced cant, new limewash on adjacent wall, and new mortar joints

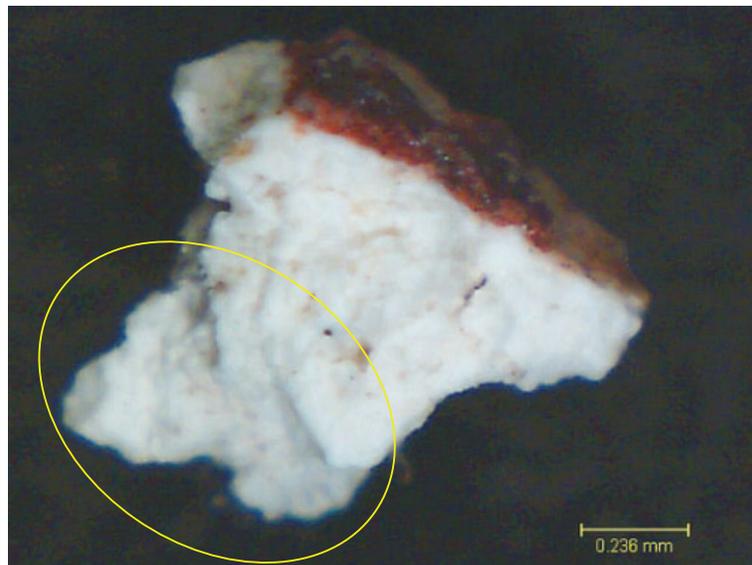
External surface and back side of the maybe 0.2 mm thick surface of the particle in figure 7.1.5 were analysed with quite different results. Only the external surface showed detectable amounts of gypsum, the backside showed a nearly pure calcite spectra (figure 7.2.3).

Figure 7.1.5: Particle used to analyse the intonaco from the small sample with red paint layer.
Part in yellow circle used for microchemical testing of salts
