Churches of Lesvos

**A Preservation Study for the Katholikon
of Moni Perivolis and Other Historic Churches**

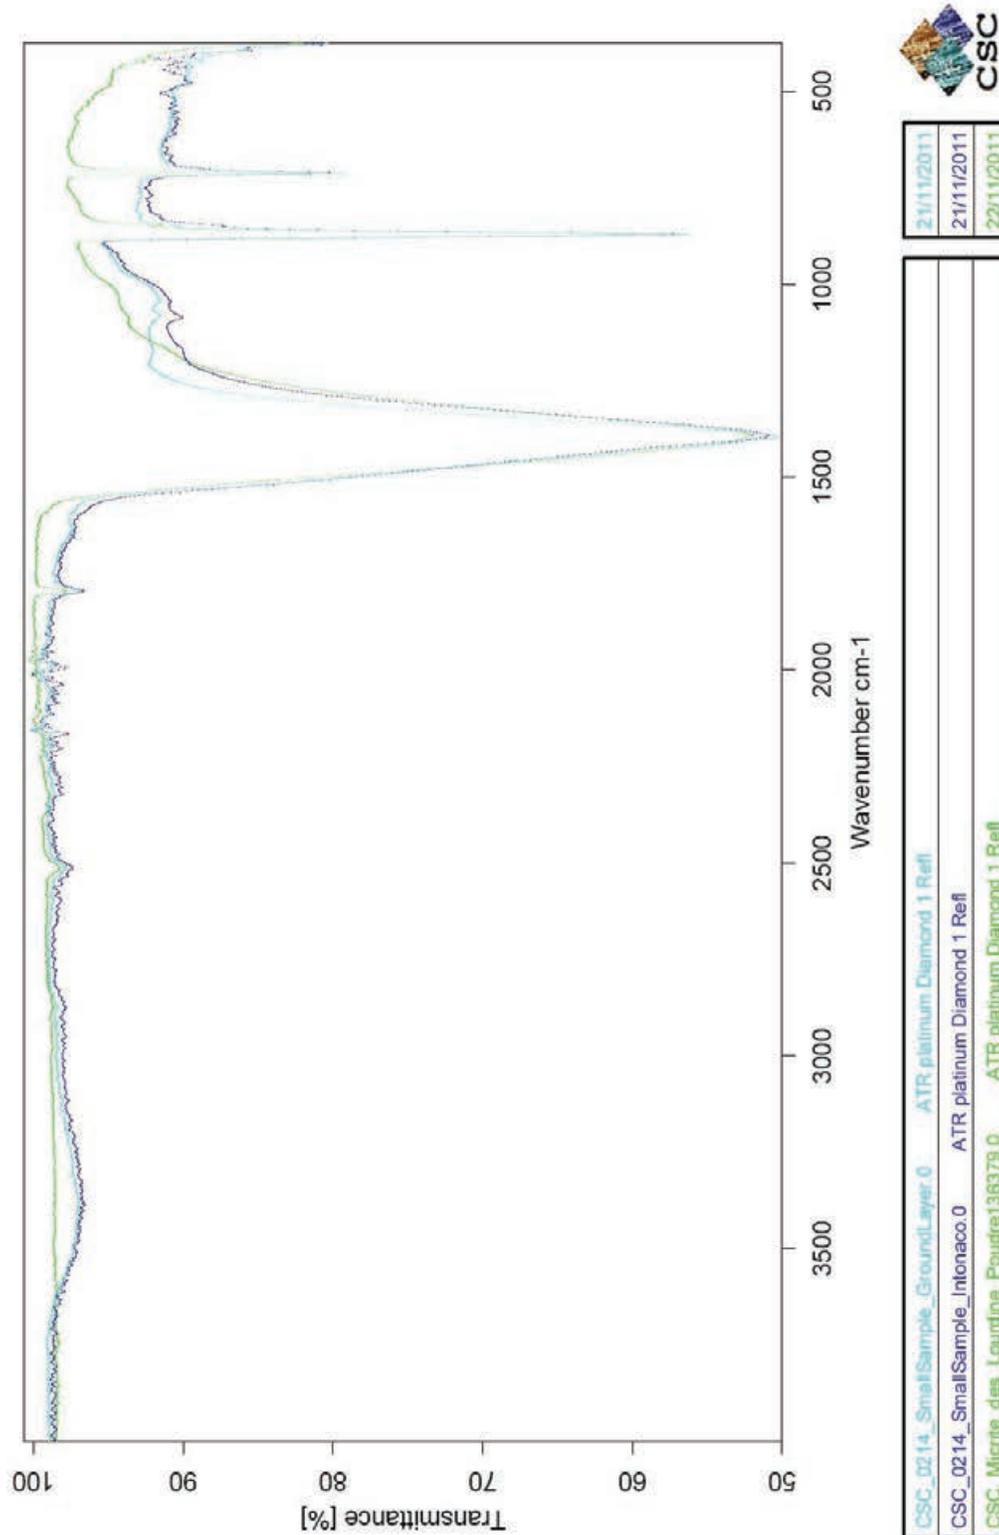
In the samples of the both mortar layers calcite (CaCO_3) is the main constituent (see FTIR-spectra in figure 7.2.1). From the same FTIR-spectra it can be seen that the samples probably contain some hygroscopic water (peaks in the 3500 cm^{-1} region) and probably silicate minerals (small peaks in the 1100 cm^{-1} region).

Figure 7.2.1: FTIR spectra of the two mortar layers (without the plant material) compared to a limestone (micrite) containing nearly only Calcite (CaCO₃)
